# Changes in the Dynamic Properties of an Experimental Building by Ambient Vibration and Forced Vibration Analysis

Laura Gabriela Ortiz-Huerta<sup>1</sup>, Luis Humberto Mendoza Garcilazo<sup>2</sup>

Centro de Investigación Científica y de Educación Superior de Ensenada, México

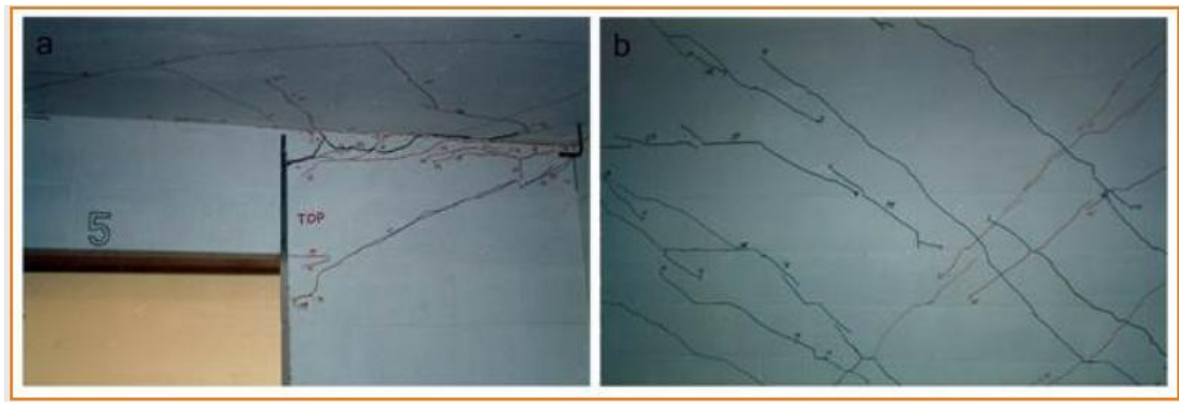
Greater loads were introduced at the lower levels, considering that these levels naturally experience greater load concentrations. Lateral forces were distributed across the slab area at each level by rigid loading via two beams ( $W 18 \times 97$ ) at levels 1 through 5, connected to the slab by 12.7 mm (1/2 in) flexible elastomeric pads. The two beams provided uniform load distribution between the two loading points at each level. Force transfer between the slab and the elastomeric pads was accomplished by a frictional connection provided by four high-strength exterior bars, which held the load-bearing beam and slab together with a normal force of approximately 224 kN (50 kip) per pad or per support. An example of cracking in the building's walls and slabs resulting from loads induced by the hydraulic actuators is shown in Figure 7.

Figure 7. Cracks or fissures in the roof slab or level 5, and in the east wall of level 2. Compressive cracks are indicated in black, and tensile cracks are indicated in red. Photograph: Luis H. Mendoza, 1992.

- Use of polymer-based concrete to patch the most affected cracked concrete areas, such as at the base of walls and door lintels.
- Injection of "epoxy resin" into the cracked joints between the floor slab and the base of the wall.
- Reconstruction and reinforcement at the base of the joints between the walls of level 0 of the building.
- Reinforcement of floor slabs to withstand shear stress using various methods: synthetic foam, sealants, and a structural mortar, "Silka Grout 212".
- Reinforcement of the lintels.

-Carbon fiber layers in the walls corresponding to the first two levels to cover the critically damaged walls in order to reduce shear deformation and increase wall rigidity.

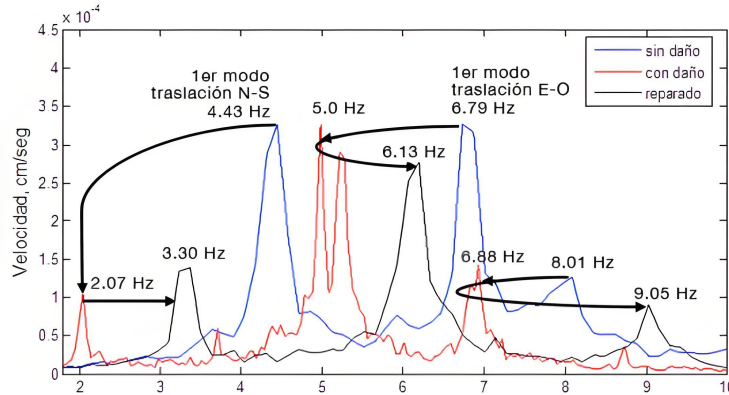
Figure 15. Amplitude spectra of ambient vibration observations from level 5 of the building's north face in its three stages: undamaged, damaged, and repaired, respectively. The arrows indicate the change in frequency of each of the building's normal modes.

The first translational mode in the north-south direction, with a frequency of 4.43 Hz, decreases to 2.07 Hz after the building was damaged, and increases to 3.30 Hz once the building was repaired or reinforced. The same behavior occurs with the translational mode in the east-west direction at a frequency of 6.79 Hz, whose frequency decreases to 5.0 Hz in the damaged building and increases to 6.13 Hz in the repaired building. The highest frequency mode (8.01 Hz) in the undamaged building corresponds to a low-amplitude translational mode in the east-west direction. This mode is not observed in the damaged building, but instead a torsional mode is observed at a frequency of 6.88 Hz; and a higher frequency torsional mode (9.05 Hz) is observed in the repaired building.

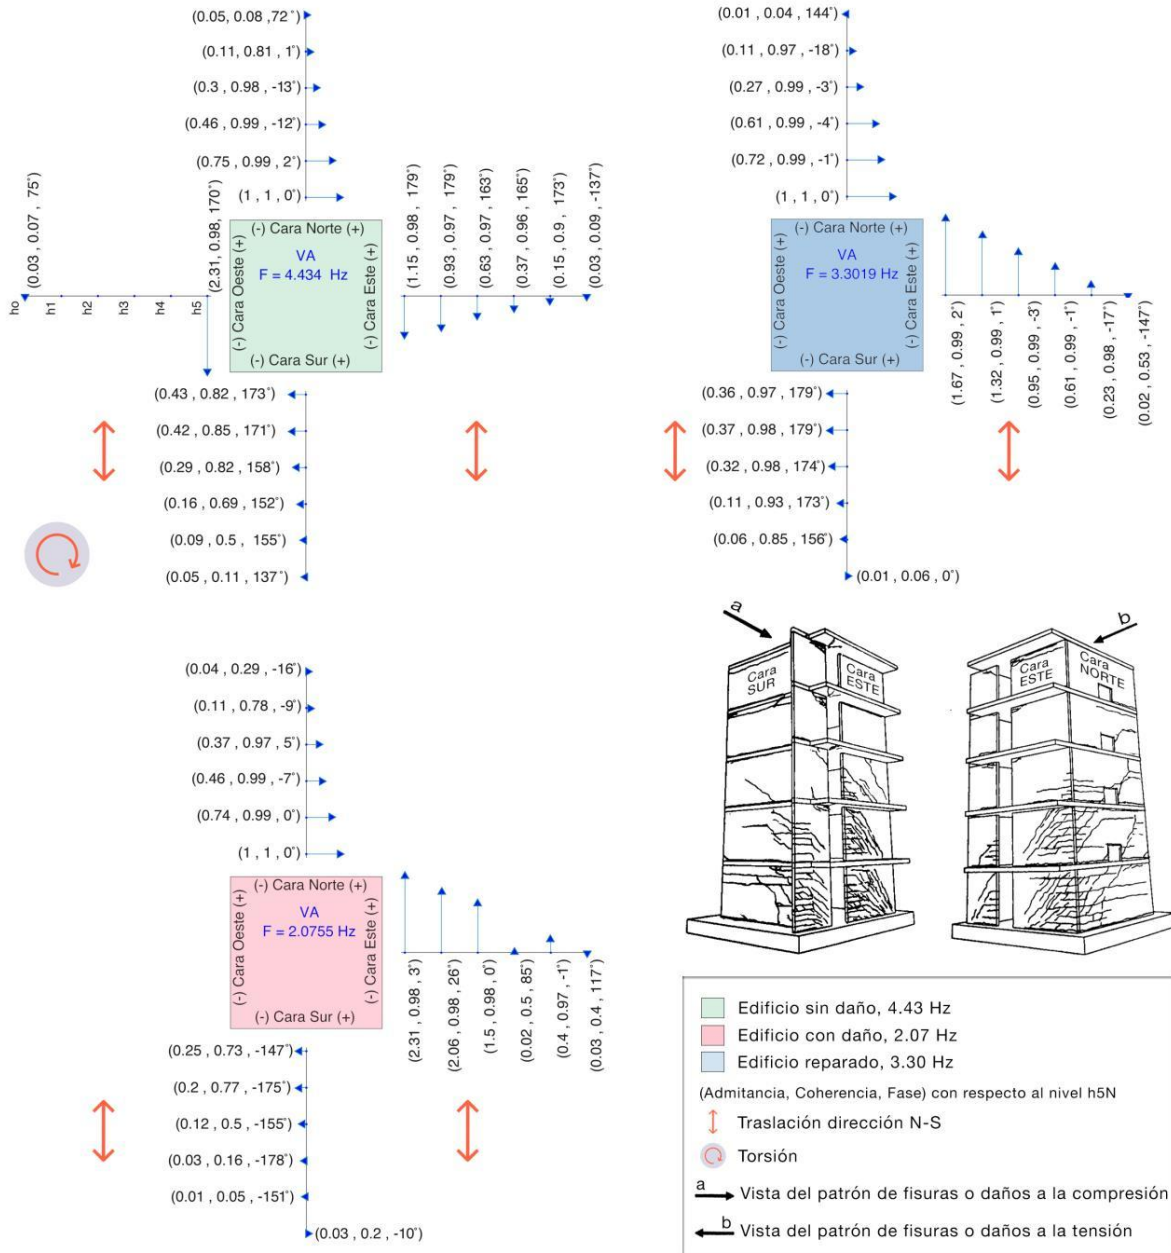
In order to identify the building levels where the greatest damage occurs, emphasis is placed on observing the modal shape at the frequency of 4.43 Hz on the east face of the undamaged building (Figure 16), to contrast it with the corresponding modal shape of the damaged building, where it can be seen how the relative amplitude is amplified at levels h3, h4 and h5, and how a "node" appears at level h2 of the east face, a level where coherence decreases from 0.96 in the undamaged building to 0.5 in the damaged building. The same Figure shows how the greatest damage inflicted on the building by tension and compression was recorded between levels h0, h1 and h2, on the east face, because the reaction wall of the hydraulic actuators is located parallel to the north face of the building. Once the experimental building was repaired, the shape of the first north-south translational mode on the east face can be seen to have recovered; however, its corresponding frequency only recovers up to 3.3 Hz, indicating that stiffness has been restored, but not completely. In fact, Seible et al. (1994) indicate that 50% of the original stiffness has been recovered.

Figure 16. First translational mode in the north-south direction in the undamaged (4.43 Hz), damaged (2.07 Hz), and repaired (3.30 Hz) buildings, for the ambient vibration spectral component. The building schematic shows the pattern of cracks or damage due to hydraulic actuators (Seible et al., 1994).

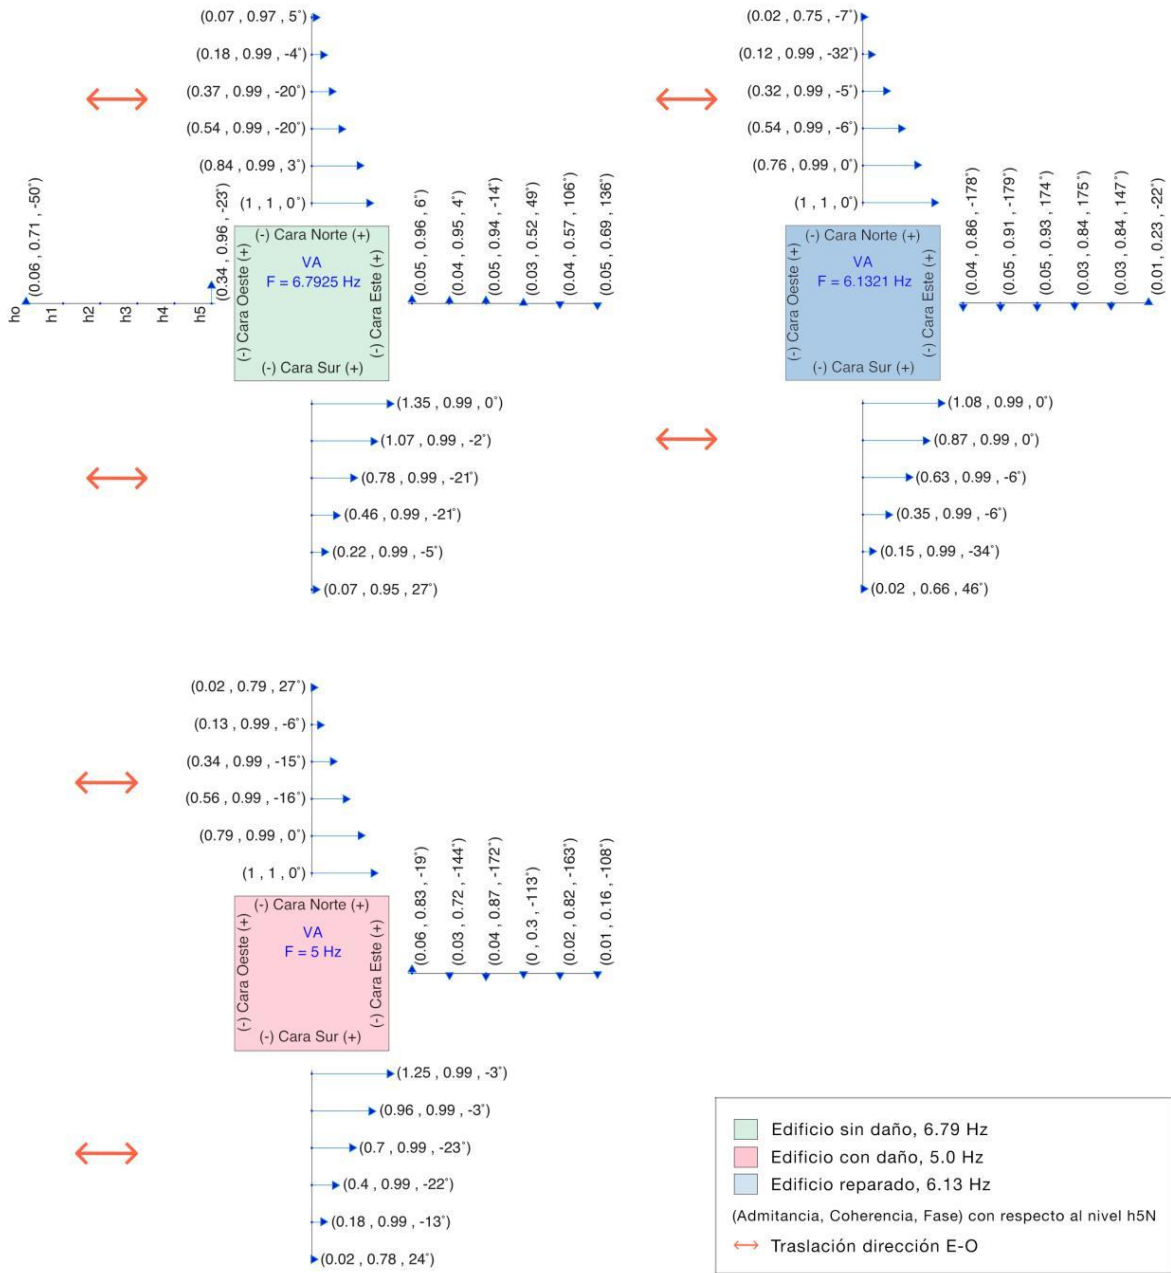
In the east-west direction, no significant changes in modal shape were observed across the three stages of the experiment (Figure 17). Only changes in frequency were observed, consistent with the degradation and recovery of its stiffness.

Figure 17. First translational mode in the East-West direction in the undamaged (6.79 Hz), damaged (5.0 Hz), and repaired (6.13 Hz) buildings, for the ambient vibration spectral component.

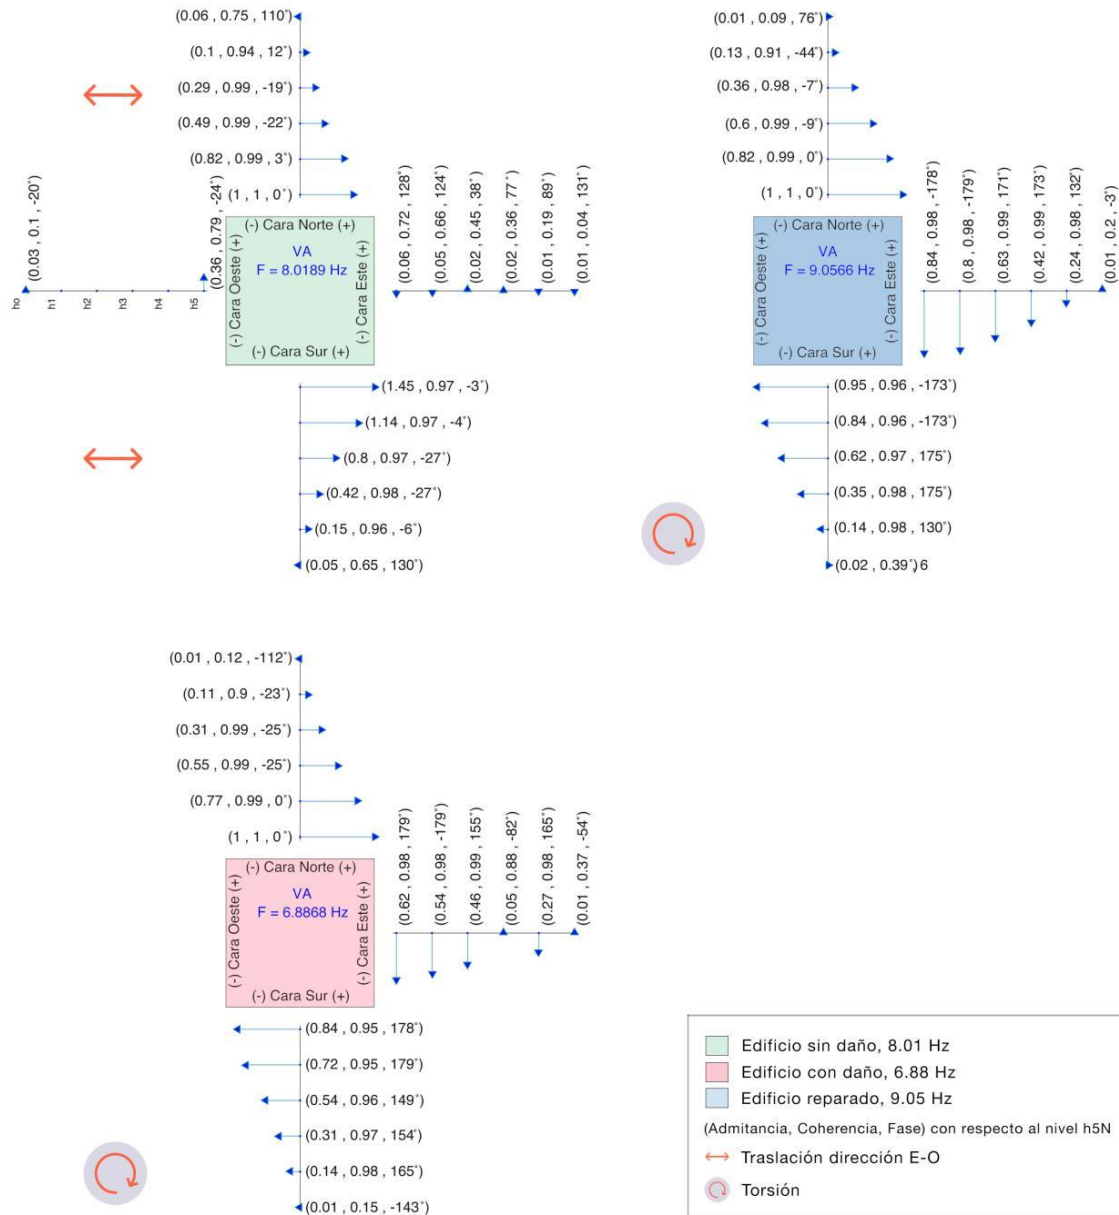
In the higher frequency mode shapes (Figure 18), it can be seen how the east-west translational mode (8 Hz) changes to a dominant torsional mode (6.88 Hz) once the building has been damaged. However, while torsion is clearly observed at all levels of the north and south faces and at levels h5, h4 and h3 of the east face, a "node" is observed at level h2 of the east face, similar to the "node" observed in the first translational mode at the frequency of 2.07 Hz in the damaged building. Note that the node observed at level h2 of the east face coincides in its location with the damage observed in the walls corresponding to levels h0, h1 and h2 of the east face, which is the face where the greatest damage due to the hydraulic actuators was recorded.

Figure 18. Response of the undamaged (8.01 Hz), damaged (6.88 Hz), and repaired (9.05 Hz) building to the ambient vibration spectral component.

The change in the frequency of the modal shape, from 6.88 Hz to 9.05 Hz, once the building has been repaired, could be indicating that this mode does not correspond to the previous ones because it exceeds the frequency of 8.01 Hz observed in the first stage of the building, as if the stiffness had increased after the repairs.
