Impact of Amazon environmental conditions on the deterioration of soil-cement block coatings

Bruno Lôbo de Almeida, Samuel Oliveira de Queiroz, Isaura Nazaré Lobato Paes, Luciana de Nazaré Pinheiro Cordeiro

Federal University of Pará-UFPA, Belém, Brazil

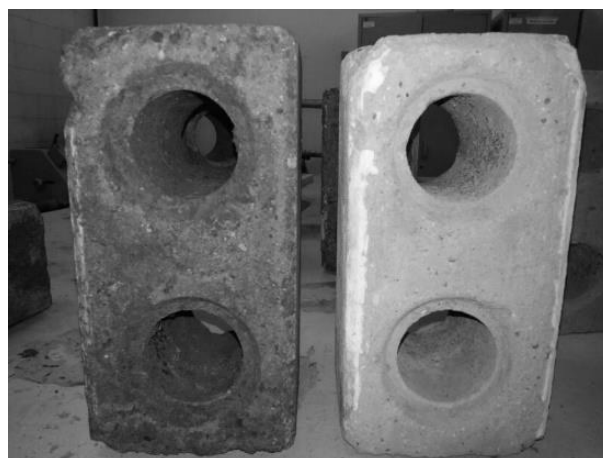
Figure 1: Image of soil-cement block samples taken from the construction site. Source: the author

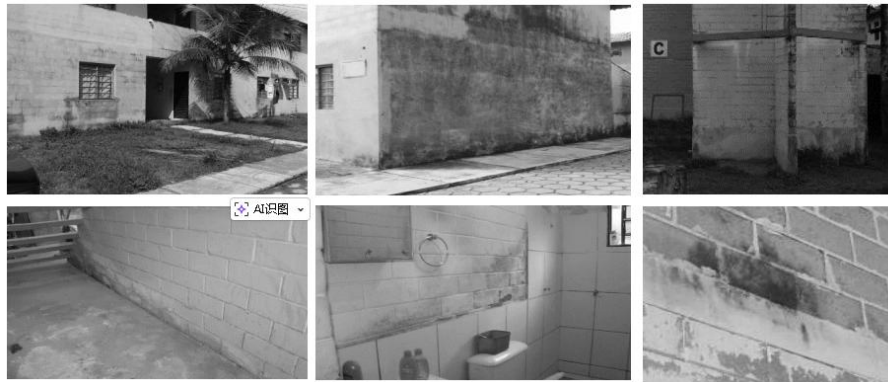
In parallel with the determination of regulatory characteristics through sampling of the soil-cement blocks, technical site visits were conducted, which enabled detailed mapping and the identification of various pathological manifestations, such as: fungal growth and blistering in finishes, leaks, efflorescence, stains, and paint wear (exterior) and ceramic tile detachment (interior: kitchen and bathroom), as illustrated in Figure 3. The on-site analysis reinforces the importance of continuous monitoring and planned maintenance strategies to prevent the progression of these issues, as well as the revision of construction practices to better adapt to the local climate and conditions of use.

Figure 3: Set of pathological manifestations found in the residential building. Source: the author

It was observed that the deterioration stemmed from various factors, some of which have been widely discussed in the literature but which the technical community continues to repeat, such as design flaws, incorrect material specifications, and construction errors; and that, in this case, the consequences were visibly exacerbated by local climatic conditions; that is, the interaction of facade cladding with climatic phenomena must be considered to ensure the system's durability. In this regard, research is currently being conducted to identify the factors that trigger and accelerate deterioration phenomena, particularly with regard to the unique conditions of the Amazon region (CARDENAL, 2017; SANTOS et al., 2019; BORGES et al., 2023; NETTO et al., 2023)[18,19,20,21].

cladding that led to the emergence of a large number of cracks. These cracks, on their own, would not be so harmful were it not for the deterioration mechanisms that may have originated from them, since water penetrates the porous microstructure of the materials through them and also causes other problems for the buildings and their components, such as the white stains characteristic of efflorescence and dark stains resulting from the proliferation of microorganisms.

Given the above, it is clear how important it is to improve the waterproofing characteristics of buildings to prevent water penetration. However, the waterproofing system is often neglected during construction, particularly in low-income housing, as observed in this case study. There were no plans or technical notes that shed light on which areas had actually been waterproofed or which product(s) and technique(s) were used. In this context, several studies have been conducted using water-repellent products added to fresh mortar or applied as a protective surface barrier over the blocks that make up the masonry or directly over the mortar coatings (PAES et al., 2020; ALMEIDA et al., 2023; SOUZA et al., 2023) [24,25,26].
