Conservation of Housing Heritage in Coastal Areas: The Siboney Case

Abstract: The objective of this study was to conduct a pathological study of four existing housing typologies in the coastal settlement of Siboney in Santiago de Cuba, as this area is one of the highest-priority community councils for the projections contemplated in the country's strategy to address climate change. The measurement equipment and methods used for the diagnosis and characterization of the coastal settlement of Siboney are described. A survey of damage, their causes, assessments based on measurement results, and an update of technical specifications were conducted. It was stated that minimizing risks in the life cycle of buildings in coastal areas allows for planning work and resources to achieve the quality and flexibility of the areas and facilities, so that the combination of these results leads to the proposal of appropriate actions for the conservation of these buildings.

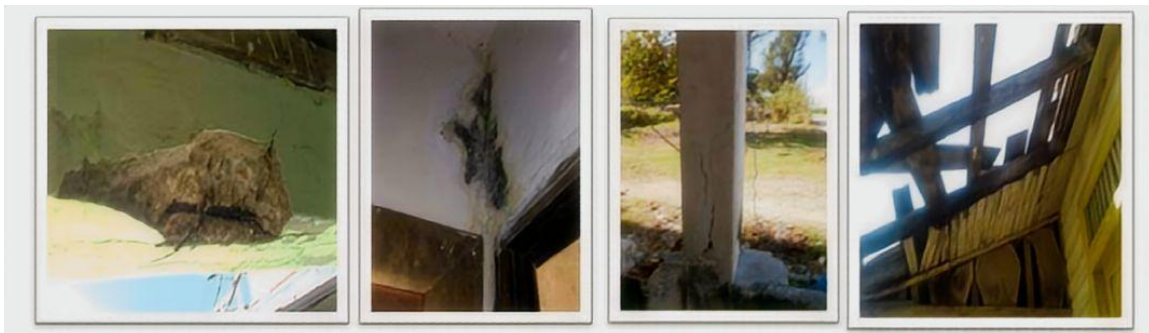
The research covers the four typologies, which, once characterized, exhibit different behaviors. Once the initial surveys and analyses are carried out, a common factor is the outdated technical conditions and the presence of pathologies such as humidity, erosion, cracks, rotting of wooden elements, and corrosion of both concrete and exposed steel. (Figure 2)

Figure 2. Evidence of the main pathologies found in buildings with construction types I (Concrete), II (Masonry), III (Masonry and Light Roof), and VI (Wood) 2018-2019. (Authors)

According to the survey, the four existing typologies show significant deterioration, exacerbated by Hurricane Sandy in 2012, which hit the province of Santiago de Cuba, and also by a lack of maintenance.
