Renovation of the Santiago Bernabéu Stadium. Live with the past: evaluation and reinforcement of the original structure

José Luis Martínez Martínez*, José Antonio Martín-Caro Álamo

Ines Ingenieros, Núñez de Balboa 120, Madrid, Spain

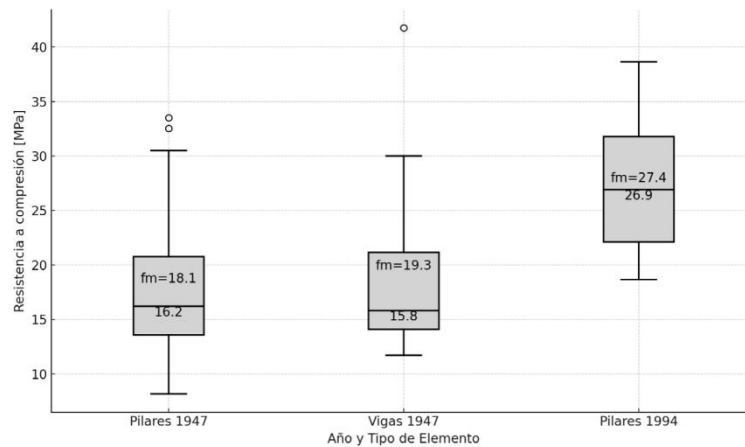
Figure 4. Distribution of compressive strength results in 100 mm diameter core samples with $h/\phi=2$. The mean value f_m and the median value are indicated

All graphical information on the structure was compiled, as well as data from four previous survey and testing campaigns carried out by Ayesa, Cones, Intemac, and Retineo. The compressive strength results (Figure 4) show coefficients of variation of around 40% for the older concretes and 25% for those from 1994. The results are consistent with an HA-15 for 1947 and HA-20 (design value) for 1994. The compactness of the concrete was investigated (UNE 83-312- 90), with void ratio results between 9% and 10% for both groups of concrete, indicating "concrete of good quality and compactness."

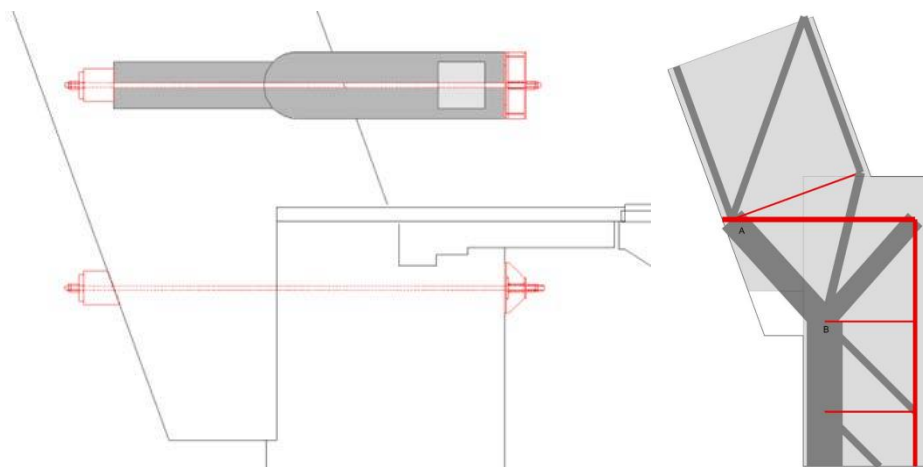
Figure 5. Rib reinforcement. Prestressed bar (i) and diagram of tie rods and struts. The heel extension allows node B to be lowered and also improves the dimension of tie rod AB

were detected at the junction of the first (vertical) and second (sloped) sections of the ribs.

The 1994 ribs experienced increased stress on the upper levels. The junction between the vertical base and the inclined section of the ribs was subjected to stress similar to that of a (large) short cantilever. The problem was studied in detail to provide reinforcement consisting of a horizontal tie and a concrete build-up. The tie consists of a $\varnothing 65$ Y-1050 steel bar within a 90 mm diameter, 5.85 m long borehole. The purpose of the concrete build-up was to increase the flange width of the diagonal section at the junction between segments (Figure 5). Although the tie was located at the center of the rib section, the tension force at the internal anchor could not be applied in the central zone because the 1947–1982 column functions as a 700 mm wide central opening near the edge. The anchor rests on a metal structure that bridges the reaction to two strips only 150 mm wide at each edge. To limit second-order effects out of plane, bracing was installed using metal trusses with a 2.50 m flange width at the top, where they were compatible with the existing installations.

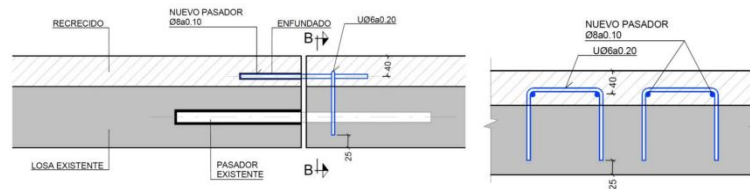
Figure 6. Detail of dowels in slab joints from 1947

The 120 mm-thick slabs required improved strength and stiffness, as well as fire protection on their upper surface. This was achieved through a nominal 45 mm-thick overlay of self-leveling micro-concrete, which increased the slab depth by 50%. The reality of the slabs' deformations and imperfections necessitated a precision point-cloud survey and the definition of an architectural elevation at each level so that the overlay would always have more 45 mm at its thinnest point. This adjustment affects both architectural elements (stairs, etc.) and effective dead loads. The slab extension is effective under normal roughness conditions, without tie bars between concrete sections and without a connecting bridge. At the joint, dowels are left in the new concrete, and bars are drilled to anchor U-bolts that prevent the dowels from being pushed out. The reinforcement of the overlay consisted of a #6 mesh at 0.15 m and $\varnothing 10$ bars at 0.15 m on the beams supporting the slab frames.

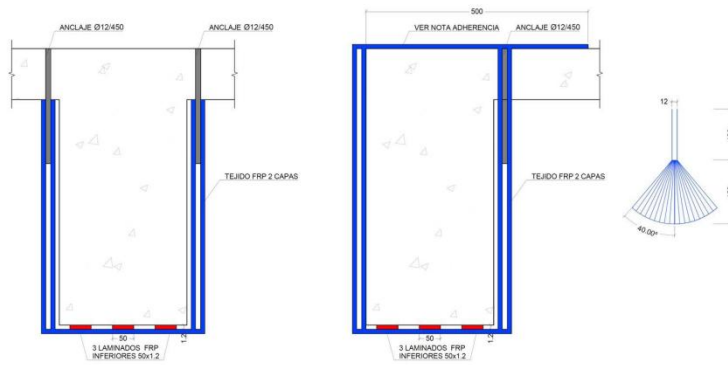
Figure 7. Detail of the anchoring of FRP shear reinforcement fabrics in interior and edge beams

The longitudinal and transverse beams do not significantly improve their safety due to the described overlay. Two types of reinforcement were designed: flexural and shear reinforcement using carbon fiber laminates and fabrics, as well as metal reinforcement. FRP reinforcement was applied whenever possible. Shear reinforcement on T-beams suffers from the problem of reduced effectiveness of the fabric applied to three faces, which also increases the stress on the positive reinforcement. To resolve this, fan-shaped anchors were used. These elements are not covered in the FRP reinforcement standards [10,11], so specialized literature was consulted [12]. Seventeen standard reinforcements were designed, each with between 3 and 9 laminates measuring 50 x 1.2 [mm] and two or three layers of 0.167 mm thick fabric.

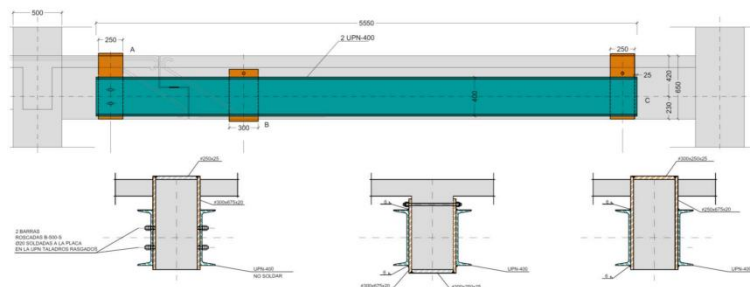
Figure 8. Typical steel reinforcement of a longitudinal beam at a joint section

FRP reinforcements are applicable up to a certain level of safety improvement required. Furthermore, in some cases it was necessary to demolish sections of beams. This disrupts the continuity of the original design and leaves the sections adjacent to the removed section with a problem in their longitudinal reinforcement, since the hooks anchoring it were located in the removed span. In these cases, an adaptation of a classic wooden beam reinforcement was used by attaching UPN profiles laterally. Where clearance allowed, metal reinforcements were used beneath the existing beams. In total, 20 standard metal reinforcement types were defined, including those found in sections with half-lap joints. All lower metal reinforcements are passive in the sense described in [13].

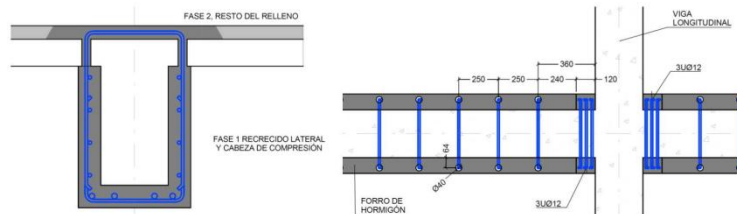
Figure 9. Section of the overlaid transverse beam and plan detail of the connection with the longitudinal beam

In the eastern floor slabs, the unique double-width span with a longitudinal beam bolted to the cross beams made standard metal solutions inapplicable. To reinforce the cross beams, which bear point loads, a perimeter micro-concrete overlay was designed, in which the stresses are resisted by the new longitudinal and transverse reinforcement. The reinforcement is conceptually similar to that of the column build-up, but its execution is considerably more complicated. The horizontal interfaces between the existing concrete and the reinforcement concrete required a high-roughness treatment to ensure the transfer of shear forces. The holes drilled in the slab to insert the vertical U-shaped reinforcement also served for pouring the micro-concrete. A similar shear reinforcement using sprayed concrete is presented in [14]. The anchorage zone with the longitudinal beam requires local reinforcement and detailed reinforcement (Figure 9).

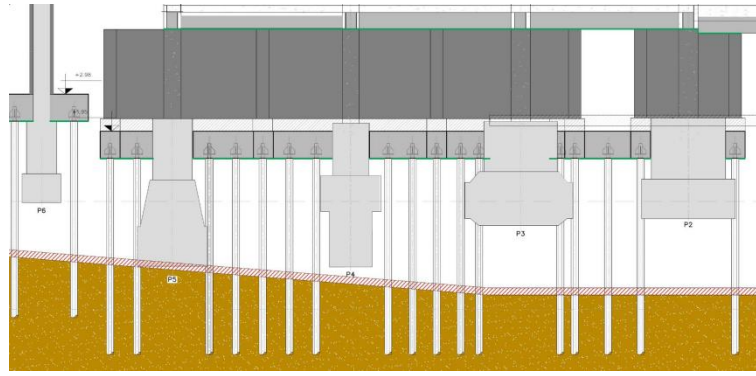
Figure 10. Partial elevation of the structure's underpinning and the lower level of the vehicle tunnel

One objective of the renovation was to provide truck access from the outside to the playing field. The layout of this access (the vehicle tunnel) defined a grade line below the foundation pits for the pillars of the east building. To construct the tunnel, it was necessary to shoring and apply load to two alignments, simultaneously supporting five pillars with a total force of 11 MN. The application of active load was considered important to prevent the shoring from suddenly bearing the load while drilling the existing pits or excavating the tunnel.

To this end, a line of formwork was constructed on micropiles and separated from the ground by expanded polystyrene. A wall beam was formed on this line, encircling the existing pillars. A gap was left between the wall beam and the foundation to accommodate 17 jacks. Once the loads were applied—which differed for each jack depending on the reactions of the corresponding pillars—shims were inserted and the gap was filled with concrete. The total movements of the structure under maximum load were less than one millimeter.

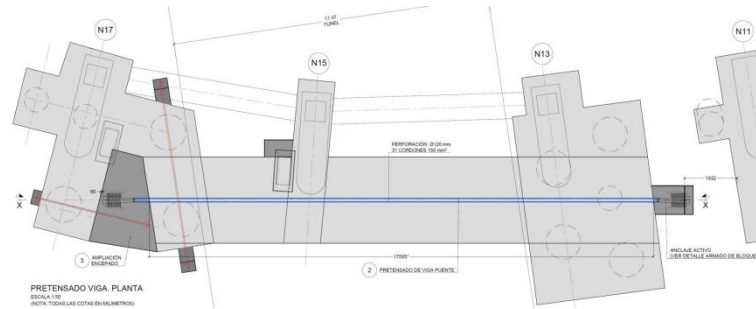
Figure 11. Plan view of one of the structures over the tunnel showing the successive interventions of 1947, 1994, and the current reinforcement. The new roof supports are located next to ribs N15 and N17

The significant increases in stress on this element (biaxial bending and torsion) were addressed with a set of reinforcements that included the stitching of several foundations and the longitudinal prestressing of the bridge girder, which required a 17.5 m borehole drilled with a misalignment of less than 60 mm. The prestressing provided additional resistance to the stresses and sufficient stiffness to prevent the reactions from straining the older parts of the structure.

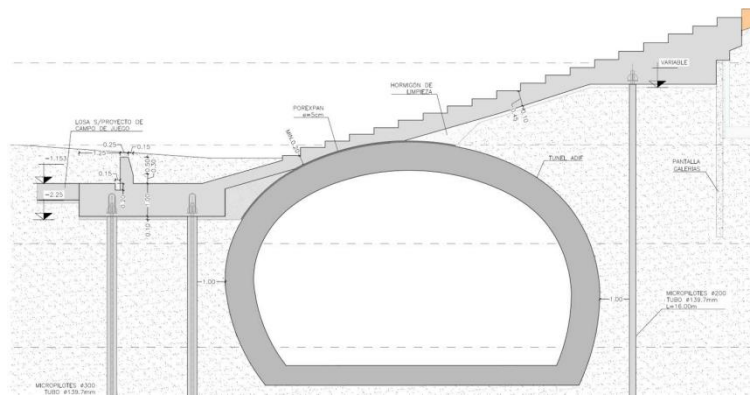
Figure 12. Cross-section of the structural grandstand and tunnel on the east side (the reinforcement of the tunnel itself is not shown)

The Atocha-Chamartín tunnel runs through the field from south to north, lying very close to the surface for much of its length beneath the east stand. The Club and Adif agreed to correct this situation through two measures: first, reinforcing the tunnel vault in the section beneath the field, and second, decoupling the grandstand from the tunnel. Thus, we had to transform this grandstand, which rested on the ground, into a self-supporting structure. The resulting structure cantilevers over the tunnel or is double-supported, depending on the area, and is coordinated with the foundation of the new movable playing field slab, described in another article in this issue.

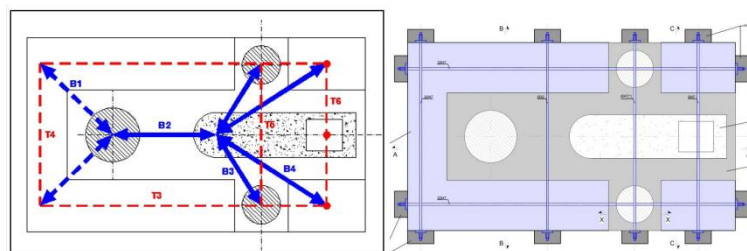
Figure 13. Plan view of the reinforced abutment equilibrium scheme (i) and extension and connection with prestressed bars of the abutment

Finally, we briefly describe the reinforcement required in eight ribs on the north end and an equal number on the south end due to the force limited by DAC devices at a rate of 500 kN per rib. Similar reinforcements were installed in the shafts of these supports—albeit on a larger scale—to those of the standard ribs (Figure 5), supplemented with FRP fabrics in the inclined section to reinforce internal ties comparable to the element's shear force. In these 16 cases, the analysis of forces at the joints revealed the need for reinforcement. It is worth noting that no new reaction elements (piles or micropiles) were required, but rather an effective internal mechanism to transfer the forces to the existing piles. Figure 13 shows the plan view of the static diagram. The eccentric axis of the rib is represented by compression in its outer zone (semicircular cap) and tension whose center of gravity lies in the opening due to the pre-existing column. The struts or tie
