The building of the former United States Consulate in Santiago de Cuba. Proposals for its preservation

Abstract: The building where the former United States Consulate in Santiago de Cuba held its sessions, a representative work of the local Modern Movement, is located in one of the main urban complexes of the 1950s in the city and has had different uses over time, currently being the headquarters of the Provincial Center for Plastic Arts and Design. This work aims to define the characteristics and values of the building and propose design solutions for conservation. Methods of historical research and the analysis of various source documents, are combined with empirical methods of observation and constructive technical diagnosis. The evolution, characteristics, and relevance of the building for the Modern Movement in Santiago are presented, placing it in its historical context, taking into account the different functions it served. Guidelines to follow in intervention actions for its conservation are also outlined.

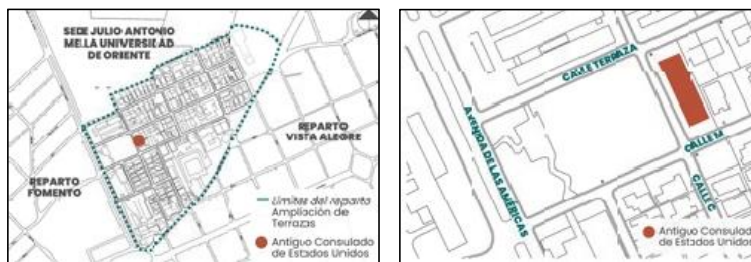
Figure 1. Left: Location of the former United States Consulate in the Ampliación de Terrazas neighborhood. Right: Detailed enlargement of the property's location within the neighborhood. Source: Authors, 2023

Towards the end of 1952, the Terrazas de Vista Alegre Development Company carried out a project to develop a new neighborhood, Ampliación de Terrazas (Figure 1), located between the Vista Alegre and Fomento neighborhoods. MoMo had a strong influence on the image of the neighborhood, which can be seen in the geometric shapes of its blocks, its road layout, the regularity of its lots or plots, and compliance with the urban regulations established for this neighborhood, such as 7-meter-wide roads with flower beds on both sides, mandatory garden space, and the limitation of vertical growth of buildings to two levels. It was further enriched by the insertion of rationalist constructions designed by Cuban architects of the stature of Rodolfo Ibarra, Margarita Egaña, Ricardo Eguilior, Ermina Odoardo, Félix Antonio Muñoz Cusiné, and

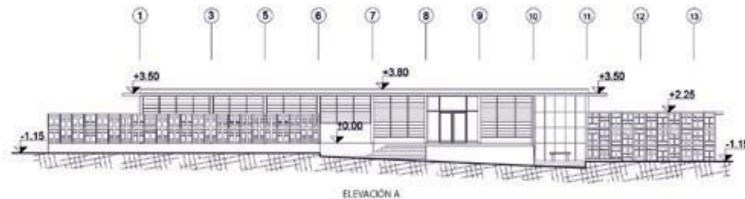
Figure 5. Elevation A of the main facade. Source: authors, 2023

The main facade (Figure 5) runs parallel to Calle C and is characterized by its horizontal shape, with the main entrance highlighted by a staircase in the central area, forming a stepped protruding volume. The lattice walls on both sides of the main entrance protect the interior of the building from the sun and provide greater privacy to its premises, accentuating its relationship with the modern architecture of the Latin American avant-garde. The composition of this facade is enhanced by a wall clad with Cuban marble slabs. In general, its sober and elegant style recalls the phrase attributed to architect Mies van der Rohe, "less is more."

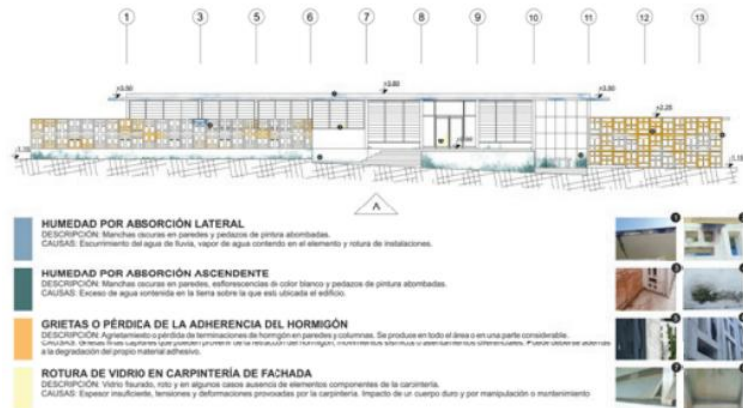
Figure 6. Damage report for elevation A. Source: authors, 2023

present in the building. These actions included observing the actual situation, creating files for visualization and location (Figure 6), describing the damage and its possible causes, and determining the area and type of intervention to be carried out. Non-destructive testing equipment, such as a rebar detector and a moisture meter, was also used to facilitate the detection of damage and understanding of the structural functioning of the building.

The damage observed is mainly related to moisture, with stains visible on the false ceiling, walls, and floors, indicating the presence of leaks. This type of damage may be indicative of sealing problems or poor-quality technical solutions, lack of maintenance, aging materials, leaks through the structure, or deficiencies in the building's storm drainage system.

There is also other specific damage to the structure of the building that may have been caused by concrete shrinkage, a phenomenon that can cause cracks and deterioration in structural elements, or by seismic movements, considering the geographical location of the building. Differential settlement caused by differences in soil compaction, which can generate stresses in the building's structure, is also observed.

The proposed intervention in the building primarily includes actions aimed at reversing the damage observed in the diagnosis, focusing mainly on the watertightness of the roof. To this end, it is proposed to replace the current waterproofing (asphalt felt) with a grid and welding, rectifying the slopes, which should range from a minimum of 2% to a maximum of 4%, and ensuring access to the roof by installing a spiral metal staircase anchored to the exterior of the building for the purpose of carrying out periodic maintenance or possible repairs.

Structural components found to be damaged during the building diagnosis, such as vertical and horizontal elements and marble pieces attached to the main facade, will be treated with materials that do not pose a risk to the integrity of the building. The carpentry and flooring will be preserved in their entirety, with work only being carried out on areas that show some type of damage.

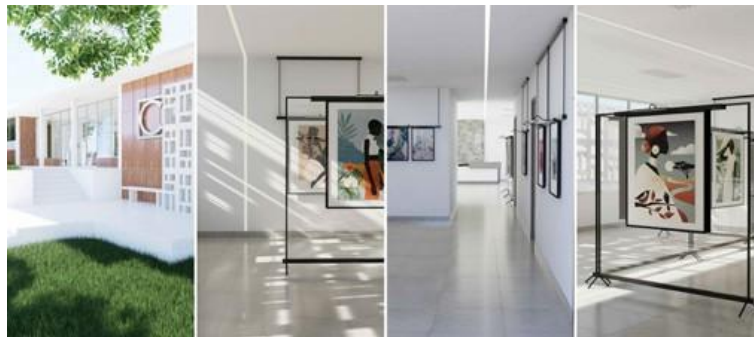
Figure 7. Interior design proposal. Source: authors and N. Romero, 2024

In the main exhibition hall, the walls will be light and neutral colors (white, cream, and light gray) to accentuate the visual contrast with the works of art (Figure 7). Direct, adjustable lighting is recommended to highlight the works of art in a focal manner. The transition from one area to another should be achieved through subtle changes in lighting that visually mark the different sections, or through flexible furniture, without the need for dividing walls. On the other hand, office areas will be implemented with functional furniture, with a clean design, in light wood or metal (Figure 8).

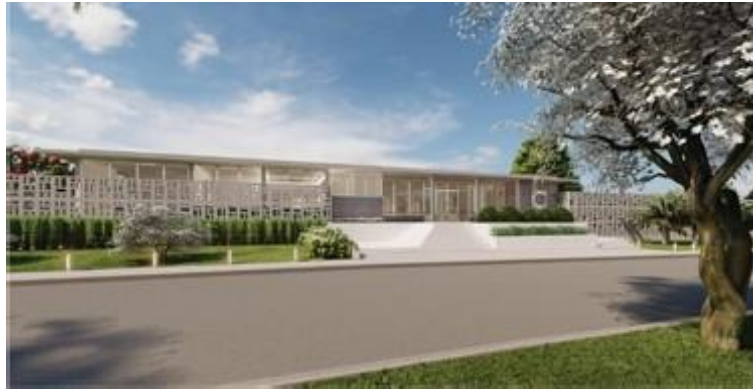
Figure 9. Proposed conservation design for the building, showing the relationship between the building and the urban components. Source: authors, 2023

The implementation of conservation measures that eliminate the causes of damage to the building, both exterior and interior, should contribute to preserving its heritage value, ensuring its mark on the immediate context (Figure 9) as a legacy of the Modern Movement for future generations. Similarly, the proposed interior design guidelines should allow the Provincial Center for Plastic Arts and Design to convey a balanced atmosphere between the way the works are displayed and the modernity(exhibited by the building).
