Study on the Causes of Highway Pavement Cracks in Desert Environment

Abstract: According to relevant statistics, more than 90% of domestic high-grade asphalt pavement is semi-rigid base pavement, and semi-rigid base cracking is a congenital stubborn disease and common. In Tengger Desert section of Wuma expressway, the temperature difference is large, and the cracking of temperature shrinkage and dry shrinkage is difficult to avoid, resulting in the decline of pavement structure strength. Once the semi-rigid base is cracked, the asphalt pavement is equivalent to a flexible structure; the residual fatigue strength is greatly reduced; the long-term service performance of pavement structure can not be guaranteed; the durability is poor, the damage layer is deep; the repair is difficult and the cycle is long; maintenance costs are relatively high. This paper analyzes the causes of pavement cracks in the harsh environment in the hinterland of Tengger Desert, and studies its mechanism and treatment scheme.

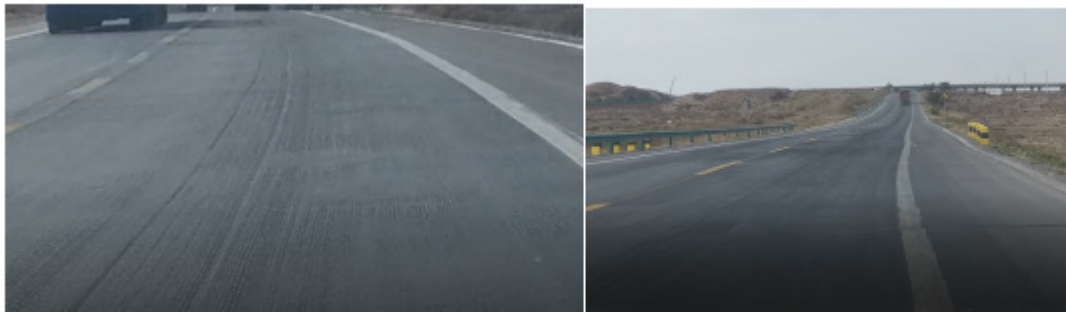
Figure 1. Road rutting disease field diagram

A rut is a longitudinal ribbon groove with a depth greater than 10mm at the wheel or rail. The causes of rutting on desert highway are complicated. Oil flash directly reduces the friction between wheels and road surface and the skid resistance of road surface. Rutting and oil spill are usually directly related to the quality, performance and material structure of highway pavement asphalt mixture. Therefore, the occurrence of rutting and oil spill disease is the result of multiple comprehensive factors. According to the different depth of rutting deformation, rutting can be divided into two types: light rutting and heavy rutting. Mild rutting is mainly characterized by shallow deformation, the depth is not more than 25mm; severe rutting is mainly characterized by deep deformation, the depth is greater than 25mm.

Most ruts are caused by instability, depression and lateral displacement of pavement materials under shear stress induced by traffic load. The appearance of such ruts is characterized by the unstable lateral creep displacement of the mixture along both sides of the ruts to form a flange. Usually occurs in the wheel-rail area of a vehicle. When the strength of roller pavement material is not enough to resist the stress imposed by traffic load, especially when heavy vehicles pass at high frequency and the road surface is repeatedly subjected to high frequency heavy load, it is easy to produce such ruts.

The rutting disease of G338 road is obvious, and the rutting disease of K1708~K1722 section is more. And the disease mainly concentrated in the road inside. Heavy trucks drive mainly on the inside of roads.

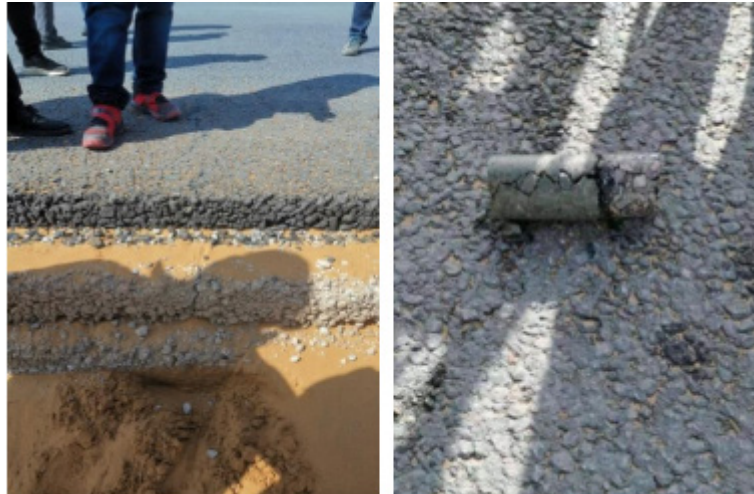
Figure 2. Crack running up to down

The cracks generated at the site of Uma expressway show that there are fewer cracks on the 8 standard road surface of Uma Expressway, and more cracks on the 9 standard road surface, and the most serious cracks on the 10 standard road surface. Pavement cracks mostly run through the upper base and the lower layer, and local cracks run through the upper and lower base and the lower layer. The fracture forms are mainly transverse cracks, and the longitudinal cracks, cracks and mesh cracks are rarely seen or not found. The structural damage caused by rolling of transport vehicles can be excluded.

The found cracks basically run through the upper and lower levels, and most of them occur in the desert section 9 and

10. They are temperature shrinkage cracks at the base level caused by the large temperature difference between day and night in the desert. The cracks are reflected from the base to the asphalt surface and produce transverse cracks. In addition, the semi-rigid base of cement-stabilized gravel itself will also produce cracks and reflect to the asphalt surface due to dry shrinkage. Therefore, when considering the structure of desert highway asphalt pavement, it is necessary to consider the structure of blocking or slowing down the reflection cracks of the semi-rigid base.section.

The following measures are put forward to prevent the crack of asphalt pavement in desert expressway:

(1) By controlling the three indicators of asphalt, selecting asphalt with excellent performance and good low temperature sensitivity based on reasonable grading and advanced construction technology, the low temperature crack resistance of pavement can be improved.

(2) When the dry shrinkage crack of semi-rigid base of cement-stabilized macgravel is nearly complete, laying asphalt surface layer can reduce the reflection crack caused by dry shrinkage.

(3) The asphalt mixture design is scientific and reasonable, and the skeleton dense asphalt mixture is used as far as possible to strictly control the construction quality, mainly controlling the compactness and rolling temperature of the mixture.

(4) A structure is set between the semi-rigid base and the surface layer to block or slow down the reflection crack of the semi-rigid base.
