# Analysis of Seismic Retrofitting in Heritage Buildings: Techniques and Conservation Interventions

Mohammad Arif Kamal<sup>1\*</sup>, Tejwant Singh Brar<sup>2</sup>

<sup>1</sup> Architecture Section, Aligarh Muslim University, Aligarh, India

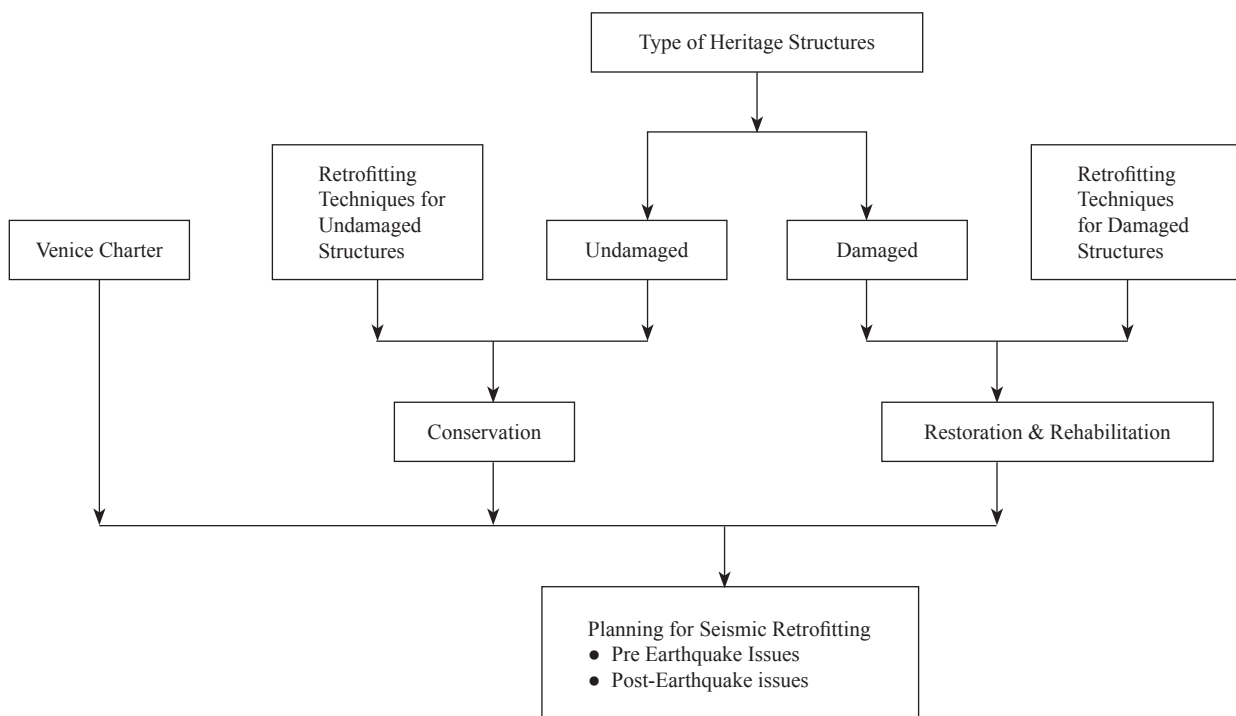
The most appropriate approach for a particular historic building will depend on a variety of factors, including the building's use, whether it remains occupied during construction, applicable codes, budgetary constraints, and projected risk of damage. From a design perspective, the vast majority of historic buildings can tolerate a well-planned hidden system of reinforcement. The figure below presents a Schematic Plan showing the conservation approach to retrofitting heritage buildings

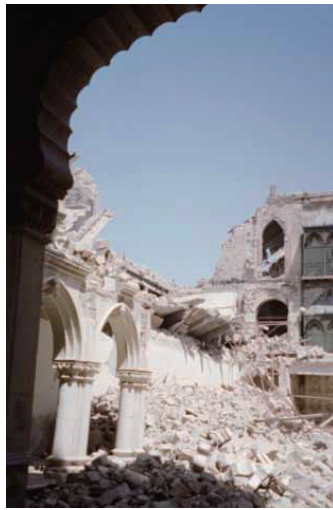
Figure 1. The extensively damaged old palace of Dabargadh

The general construction technique adopted in most of these structures was random rubble stone masonry. The binding power of lime has deteriorated with age has caused havoc for the structures. The walls are sometimes extended up to over 15

feet in un-braced height to support the ridge of the roof. Some of the constructions were open colonnade types with heavy roofs without any jointing and inadequate bearing. A heavy structure on comparatively slender and un-buttressed columns has resulted in the collapse of the structure fully or partly (Figure 1). The damage patterns seen in the various heritage buildings of Gujarat were exactly the opposite. There were numerous examples of buildings (Figure 2), which were heavily damaged at the roof and upper levels, but suffered very much less severely on the ground floor (Langenbac, 2001). Four possible reasons for the higher damage at the top of masonry buildings are as follows.

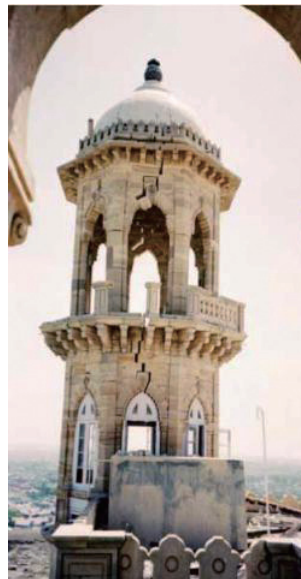
Figure 2. Eastern corner turret of Ranjit Vilas, Wankaner

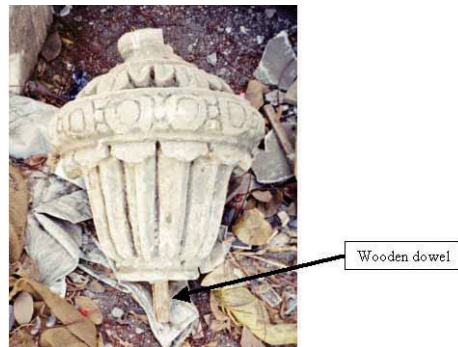
Figure 3. Ornamentation fell from roof level of Amah Vilas, Jamnagar

The swaying in an earthquake causes accelerations to increase towards the top. This especially affects decorative ele-

ments, such as parapets and external ornamentation, which were observed to be heavily damaged (Figure 3). However, it also affects main load-carrying walls, because the 'out of plane' seismic forces (ie the earthquake pushing the wall out at right angles to itself, which is its weak direction) depend directly on the acceleration at that level. By contrast, the 'in plane' seismic forces (acting along the length of the wall in its strong direction) increase towards the bottom of the building, because they are accumulated from the floors above.

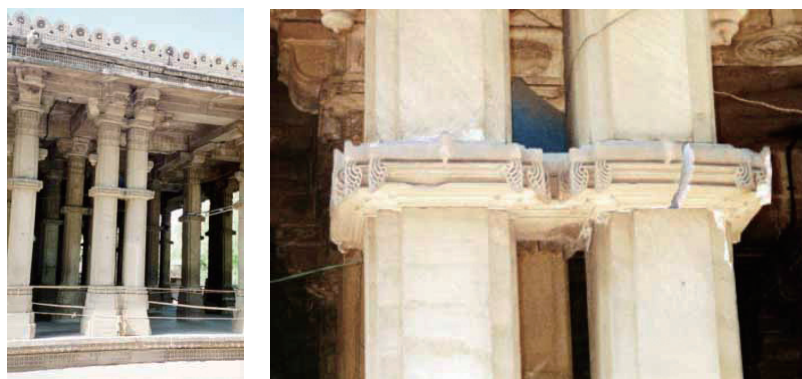
Figure 4. Overview and details of cracks at the tomb of Syed Usman at Usmanpura, Ahmedabad

The horizontal strength of dressed, good quality stone depends mainly on the vertical load from above, tending to clamp the stone blocks together. This vertical clamping force is less at the top of the building because there is less of the building weighing down from above. Therefore, the seismic resistance is also less towards the top of the building. An example of the strong beam and weak column mechanism can be seen in Tomb of Sayed Usman at Usmanpura, Ahmadabad, and also in chatris at Bhuj (Figure 4 & 5). For retrofitting of Heritage buildings there were examples of the use of reinforced concrete elements added to historic buildings at Jamnagar, Dhranghedra, and Halvad, which undoubtedly reduced the local damage suffered in the earthquake (Figure 6), although the longer-term consequences of this type of intervention may be more questionable. It is essential that the use of modern materials and technology is integrated with traditional techniques in a harmonious and compatible manner to inject new life into the building (Figure 7).

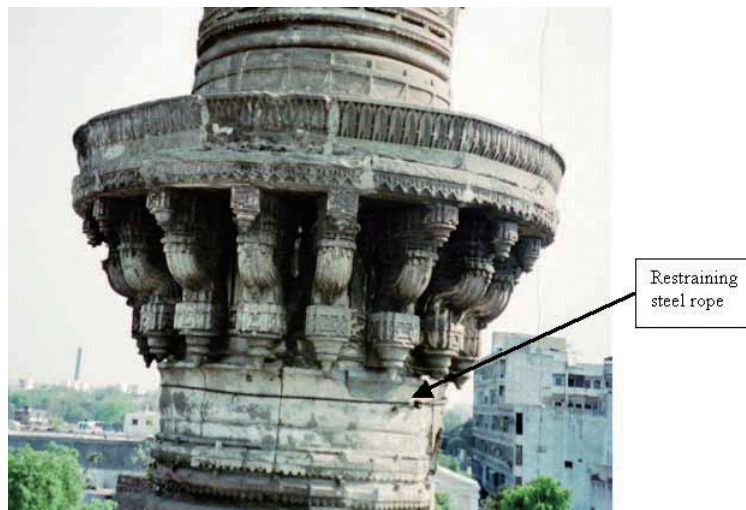
Figure 7. Stainless steel ropes introduced into the courses of cylindrical masonry structures to secure them against lateral failure in Bashir's Minars, Ahmadabad

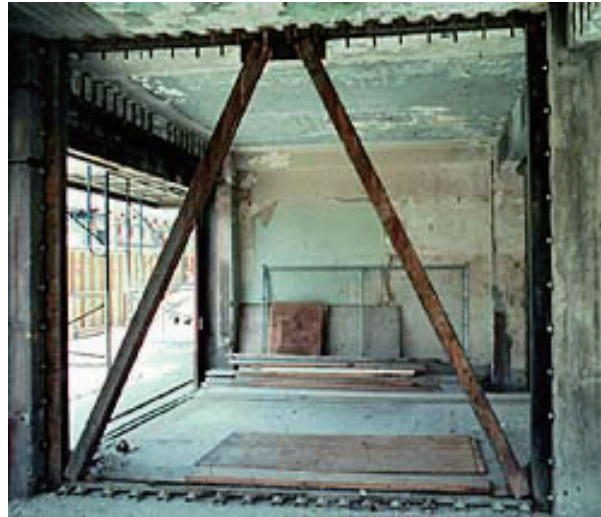
**Figure 9.** An interior diagonal frame that will dampen and transfer seismic loads in a designed path from foundation to roof

Reinforce walls and large openings to improve shear strength in locations of doors, windows, and storefront openings. Carefully locate "X" and "K" bracing to avoid visual intrusion, or use moment frames, which are a hidden perimeter bracing in large openings from a preservation perspective, the use of a more hidden system in finished spaces is generally preferable (Figure 9).

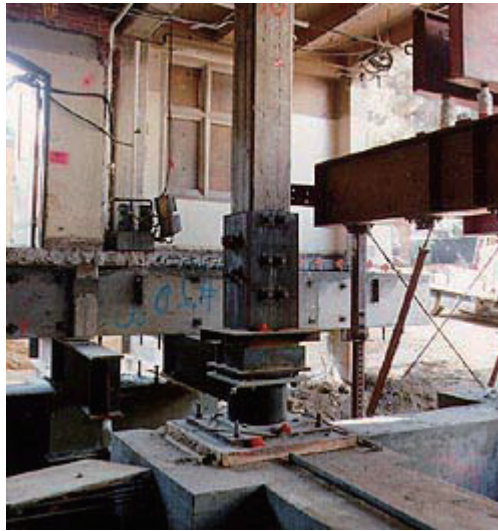
**Figure 10. The new base isolator allows the structural support member at the foundation to move horizontally as it absorbs the earthquake forces**

New technologies, being developed all the time, may have applicability to historic preservation projects. These specialized technologies include vertical and center core drilling systems for unreinforced masonry buildings, base isolation at the foundations, superstructure damping systems, bonded resin coatings and reproducing lost elements in lighter materials (Figure 10).

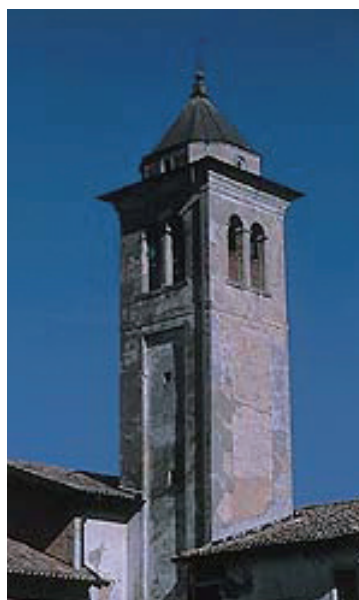
**Figure 11. The earthquake-damaged bell-tower of San Giorgio in Trigano, northern Italy, is being restored using a hidden shape-memory alloy device**

Italian SME FIP Industrial SpA is developing a revolutionary technique for improving the stability of historic monuments in earthquake zones, using 'shape memory' alloys originally employed in the aerospace industry. The ISTECH project (1) has developed a technique, which retains the natural flexibility of walls and columns, while greatly extending their resilience.

The technique developed by the ISTECH partners uses wires of the super-elastic alloy to increase the vertical compressive forces which hold a building together. In a quake, the pre-stressed masonry can still shift, dissipating energy, but will not collapse. The devices have been successfully tested using scale models and full-size masonry walls, and are currently being installed in the earthquake-damaged 14<sup>th</sup> century bell-tower of San Giorgio in Trignano (Figure 11), Northern Italy (Thakkar and Dubey, 2003).
