# Control of Reinforcement Concrete in Pile Caps over Steel Piles – Case Study

R. Boni<sup>1\*</sup>, P. Helene<sup>2</sup>

**Key words:** structural reinforcement; pile caps; concrete

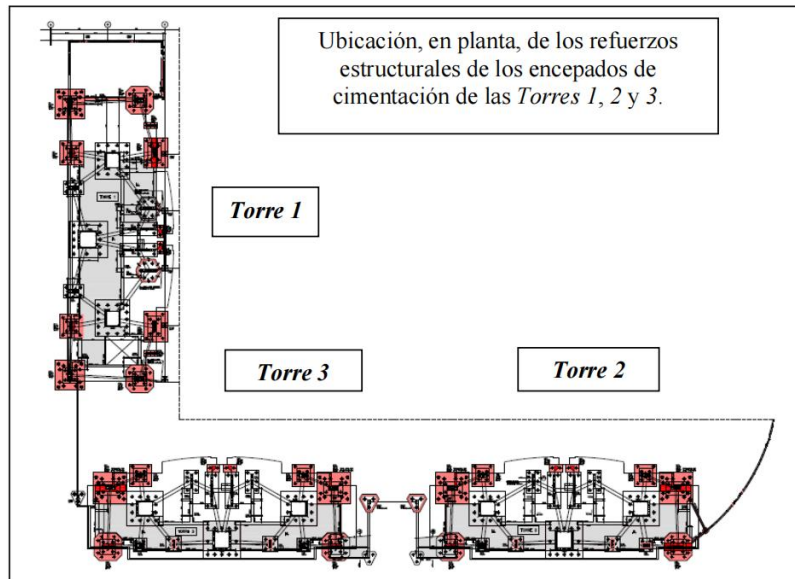
The structural reinforcement project for the foundation pile caps of residential towers has been developed in accordance with the recommendations of ABNT NBR 6118:2014 standard. This project considers the reinforcement of 20 structural elements as highlighted in Figures 1 and 2, which show the plane figure and perspective drawing of the structural

**Figure 1.** Plan details of the structural reinforcement location of the foundation pile cap of the residential tower.

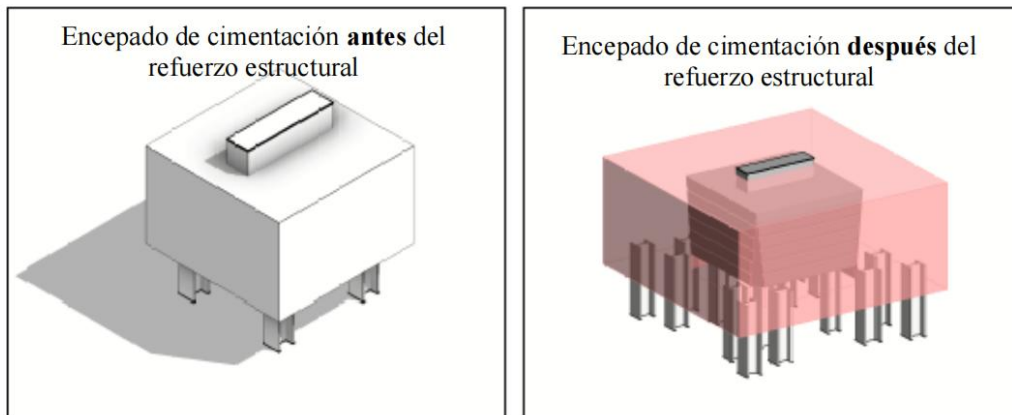
**Figure 2.** Generic detail in perspective drawings (before and after) of the structural reinforcement of the foundation pile caps.

In Figure 2, it can be seen that additional metal posts are nailed to the periphery of the existing pile caps. A total of 152 W200×86 and W250×115 profile piles were driven, with working loads of 194tf and 258tf respectively. The execution length varies from 20 meters to 22 meters. The foundation reinforcement project was developed according to the requirements of ABNT NBR 6122:2010.

This work starts with placing metal piles in the areas around the foundation piling, which will be reinforced as shown in figure 2. These piles vary in depth from 20 m to 22 m and are secured by a suitable pile driver located between the plates, as shown in Figure 7.

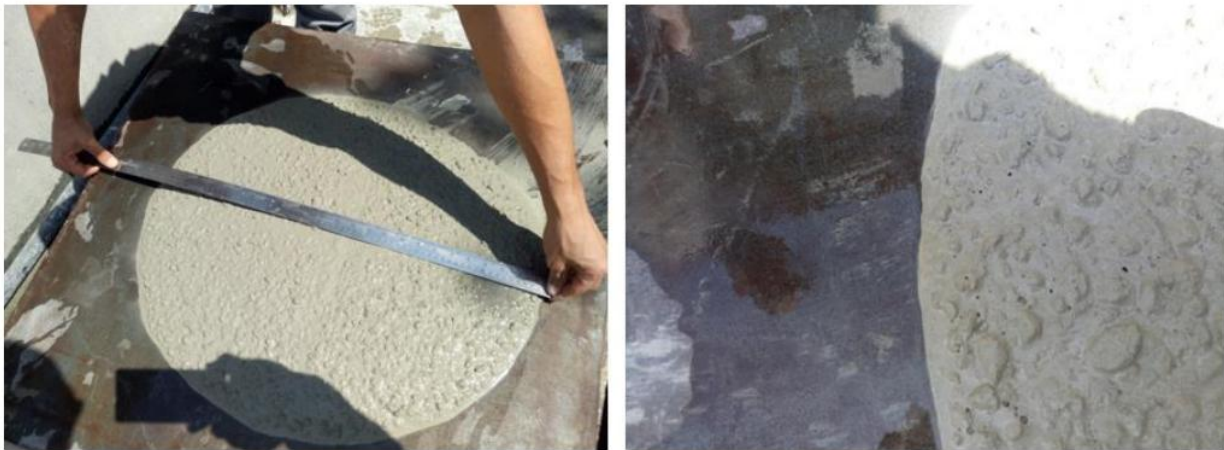
The visual appearance of concrete can be observed in Figures 3, 4 and 5, which demonstrate the dispersion, J-ring passing ability and L-box passing ability tests conducted according to ABNT NBR 15823-2:2017, ABNT NBR 15823-3:2017 and ABNT NBR 15823-4:2017 respectively. In addition, in Figure 3, it is also possible to observe the visual stability index (VSI) of the concrete that was developed especially for the structural reinforcement of the foundation pile caps of this development project.

**Figure 3.** Details of the dispersion test performed in the laboratory during the dosing study.

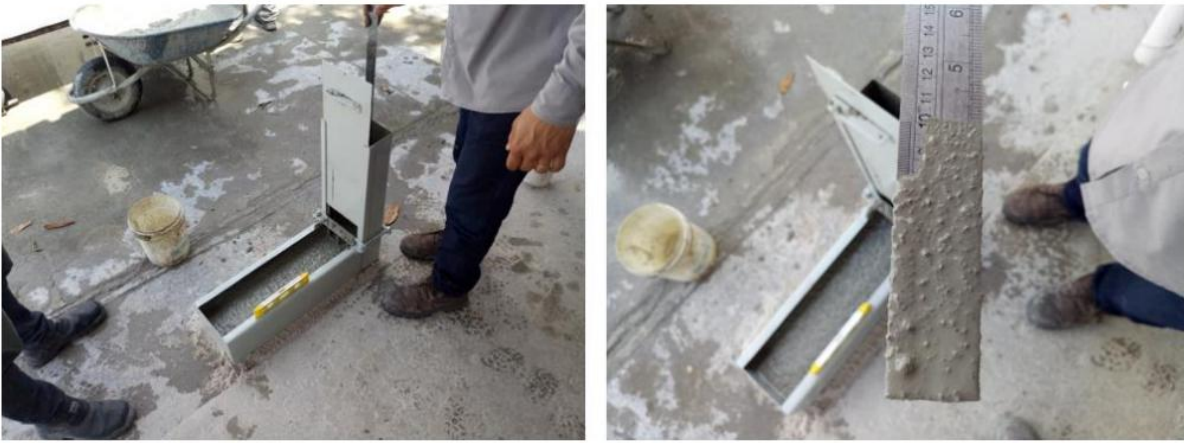
**Figure 4.** Details of the ability test to pass the L-box conducted in the laboratory during the dosing study.

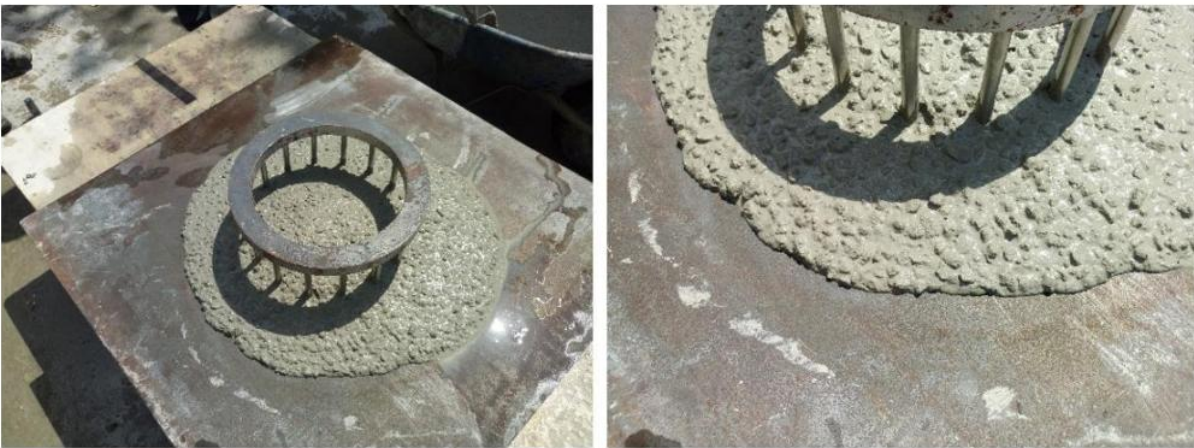
**Figure 5.** Details of the ability test to pass the J-ring conducted in the laboratory during the dosing study.

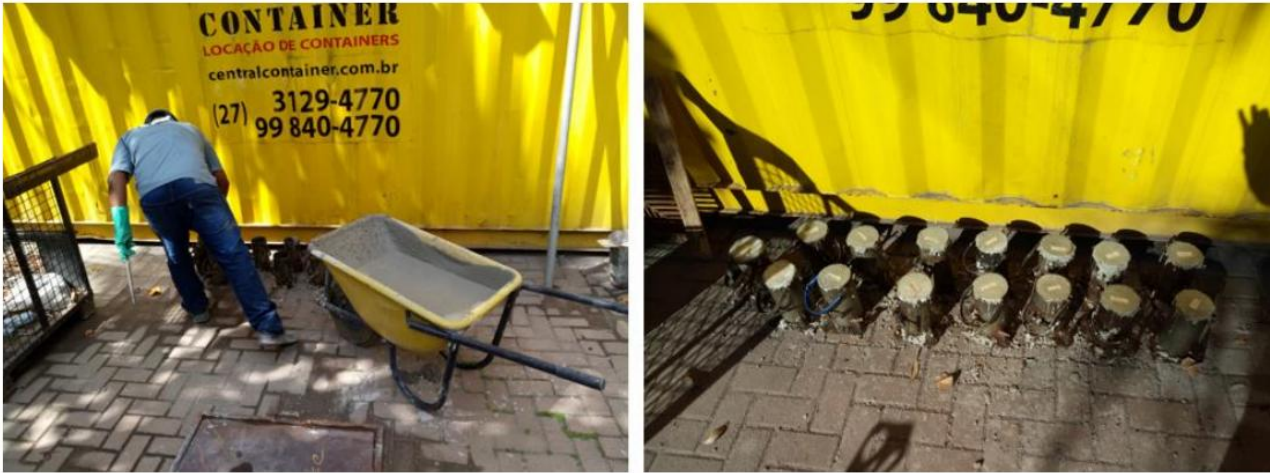
During the prototype casting event, cylindrical specimens were also cast for compressive strength tests at 3, 7, 14, 28 and 45 days of age and modulus of elasticity at 28 days, as shown in Figure 6.

**Figure 6.** Detail of the cylindrical specimen molds in the prototype casting for compressive strength tests and modulus of elasticity tests.

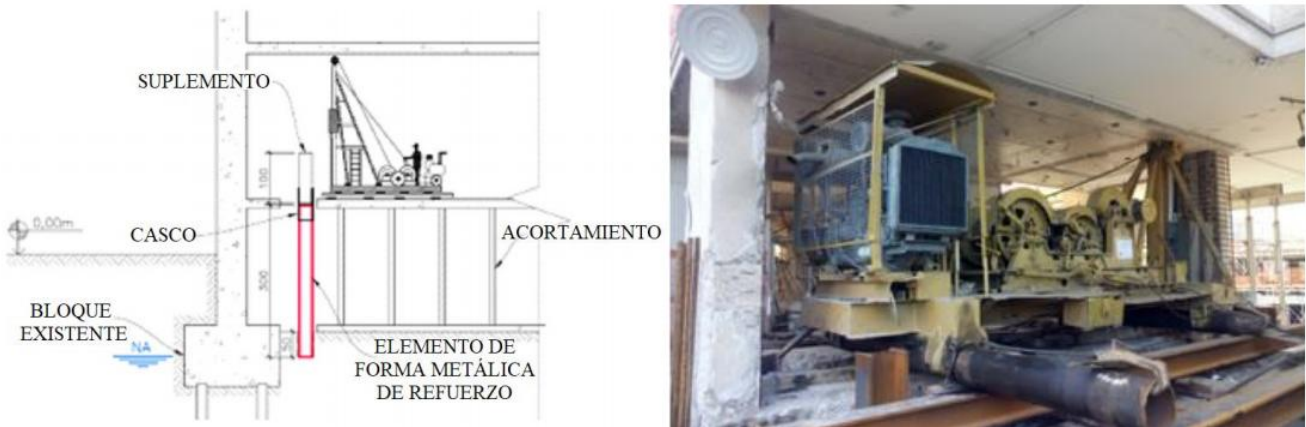
**Figure 7.** Details of a suitable pile driver positioned between the plates to perform piling services for structural reinforcement piles.

Due to the difficulty of access, the dimensions of the driving equipment and the existing interference at the site, some additional services were necessary for the execution of this reinforcement step, including:

- ✓ Pre support the road panel on the first floor, where the driving equipment is supported;
- ✓ Adjust all piling equipment so that the tower height of the pile driver is greater than the distance between the plates (right foot);

- ✓ Execute localized demolitions and holes in the first floor slab to allow the driving of metal piles;
- ✓ Pre segmentation of metal piles (variable length of 2 to 4m) to locate the profile of the drive site by drilling;
- ✓ Use a supplement (on the pilot's head helmet) to aid in contour articulation.

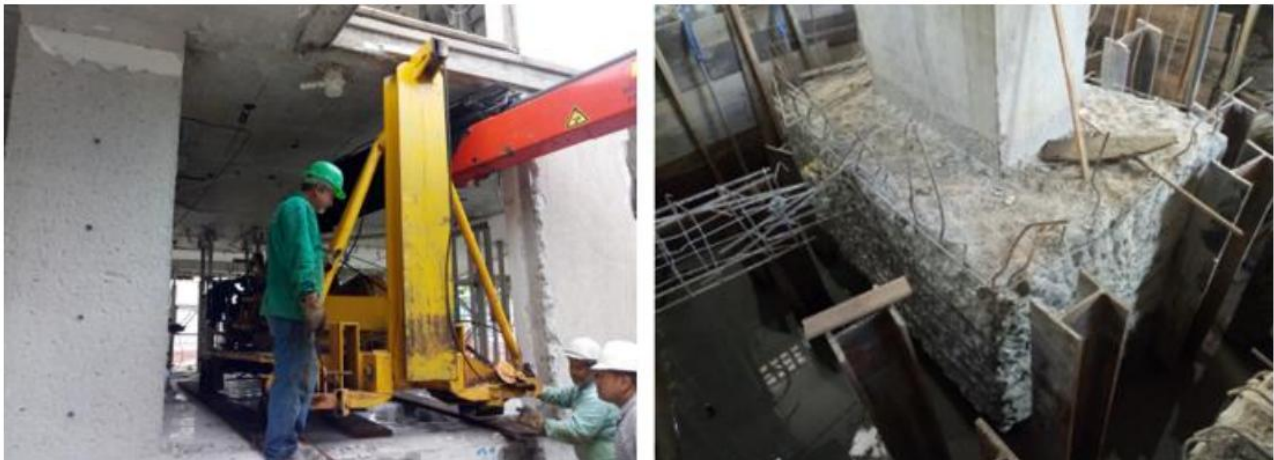
In this way, the metal segments of the piles are driven and immediately welded to the rear segments as the work progresses. Figure 8 illustrates the execution of the work and the piles driven in the perimeter of one of the foundation pile caps. In the latter case, to improve the visualization, the recording of the image was made after the excavation of the surrounding area of the block.

**Figure 8.** Detail of the execution of the piping works (on the left) and of the metal piles driven around the foundation block to be reinforced (on the right).

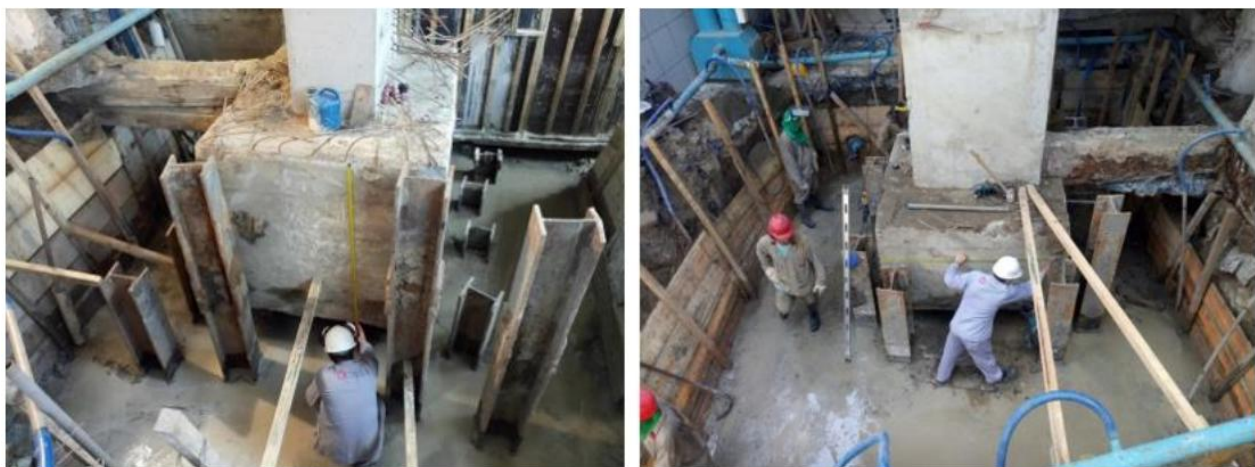
Subsequently, 5cm thick concrete was ballasted, the dimensions of the existing pile driver were measured, and the possible eccentricity of the existing pile (under load) was verified by the terrain, as shown in Figure 9.

**Figure 9.** Details of dimensioning of existing pile drivers and metal piles after concrete excavation and construction.

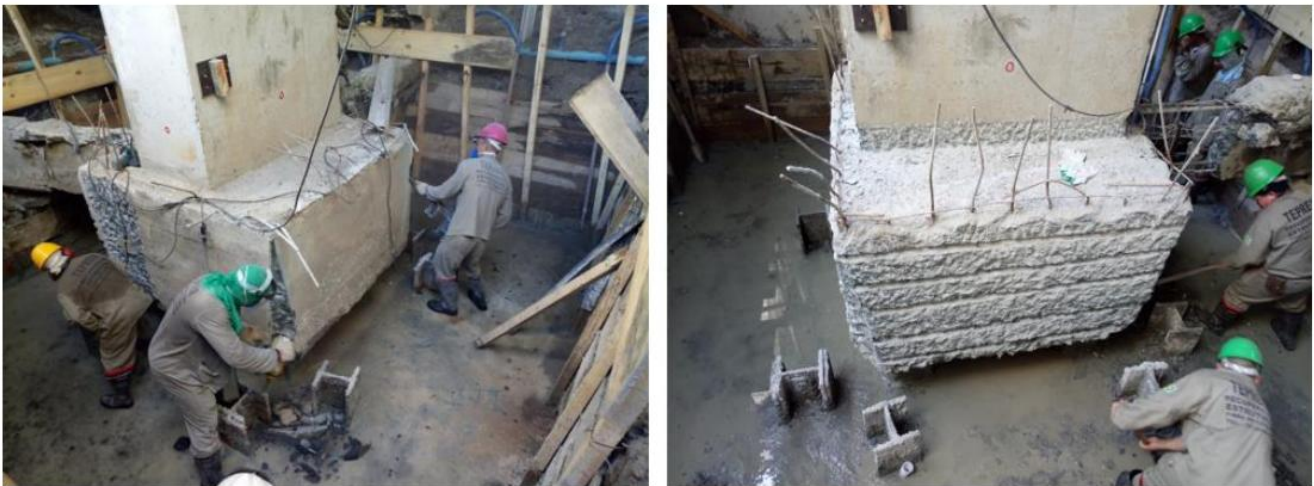
At the end of this stage, it is need to cut the pile. The pile top should be 35cm higher than the bottom elevation of the reinforcement block, and prepare the side of the foundation pile, as shown in Figure 10. At this stage, according to the requirements of the structural design, the edges and sides of the block were chamfered and grooved, and all surfaces except the bottom could not be identified.

**Figure 10.** Details of the execution of the chamfers and grooves on the edges and lateral surfaces of the foundation pile caps.

The execution of the chamfers and grooves on the sides of the existing pile caps were essential and very important, as they were intended to guarantee the quality of the pouring joint at the old concrete/new concrete interface (to be cast) and to collaborate in the transmission of forces. The execution of the chamfers on the lateral edges provided a cone-shaped geometry that dispensed with the verification of the bond between the existing block and the structural structural reinforcement.

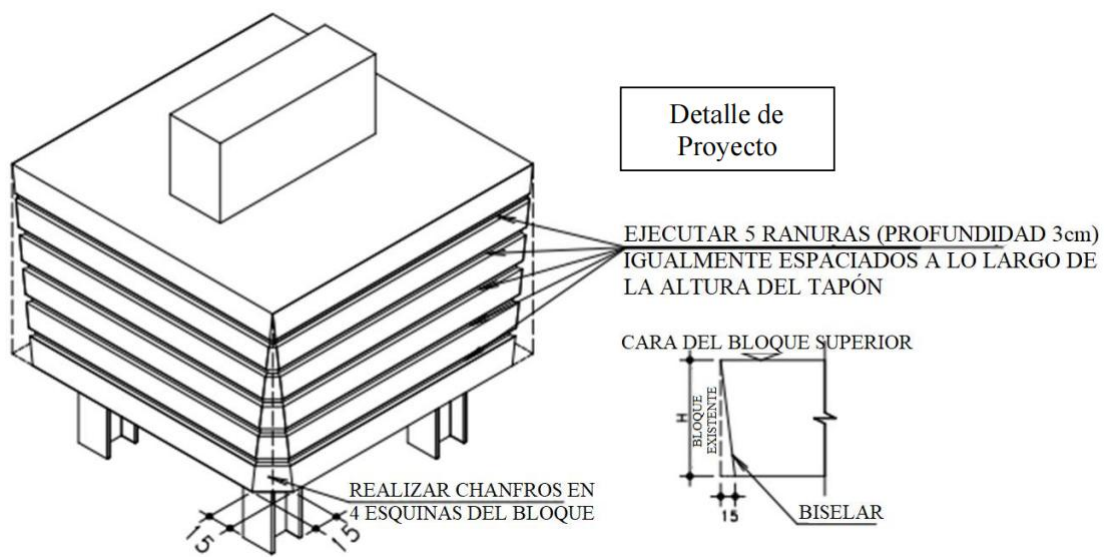
It was recorded that the grooves were executed with a depth of 3cm along the entire lateral surface and the chamfers of the lateral edges with dimensions varying from 0cm (on the upper face) to 15cm (on the lower face of the block), as shown in Figure 11.

**Figure 11.** Project details showing the location of grooves and chamfers.

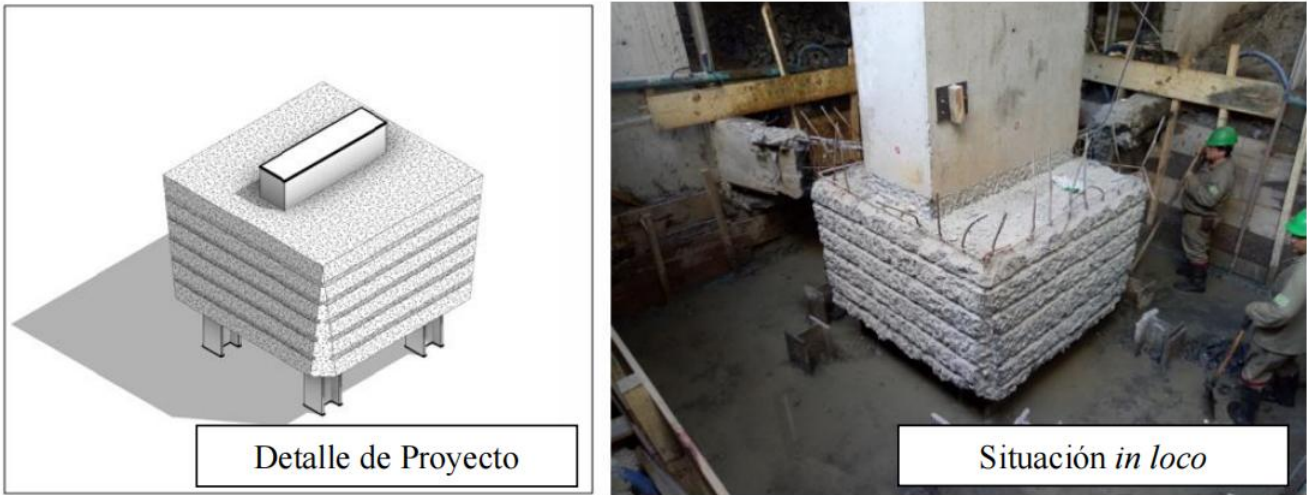
Figure 12 shows the foundation block after concrete surface treatment.

**Figure 12.** Details of the surface treatment of the foundation block. Project details (left) and on-site situation (right).

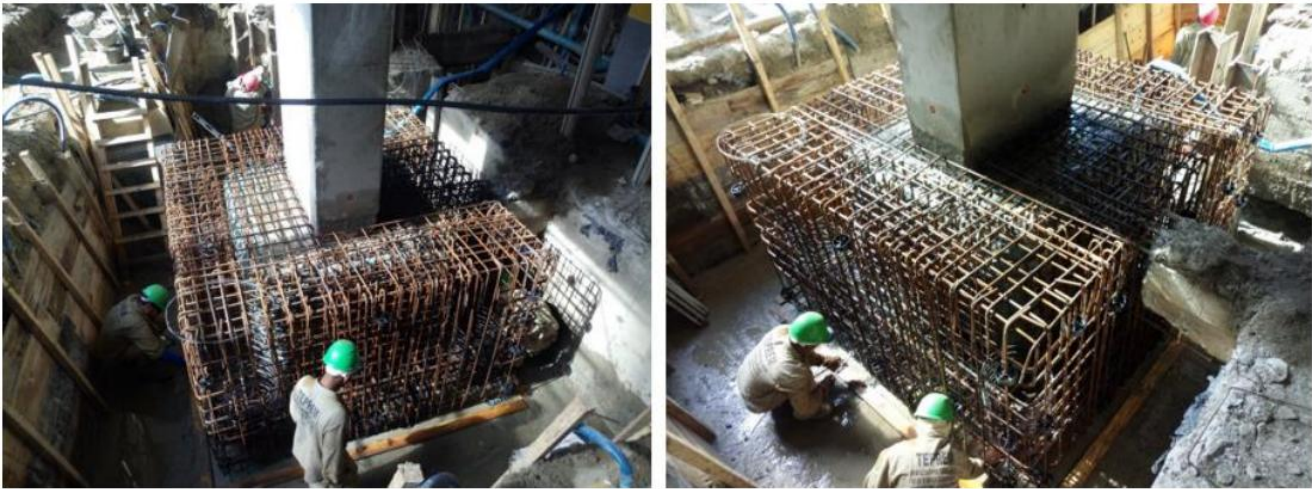
It was recorded that the steel bars used in the structural reinforcement of the pile caps (measurements 25mm, 20mm, 16mm and 12.5mm) were delivered to the site cut/bent and duly identified. Figure 13 shows the execution of the pile cap reinforcement work.

**Figure 13.** Details of the execution of the reinforcement work of the foundation block.

After the surface treatment, they started the reinforcement of the structure by a professional company and certified workers, and accompanied and thoroughly verified the project, involving the location, measurement, reinforcement quantity and other quality control stages, including the use of multi-support type spacers on the sides and bottom of the block, in order to ensure the overlap specified in the project (40mm).

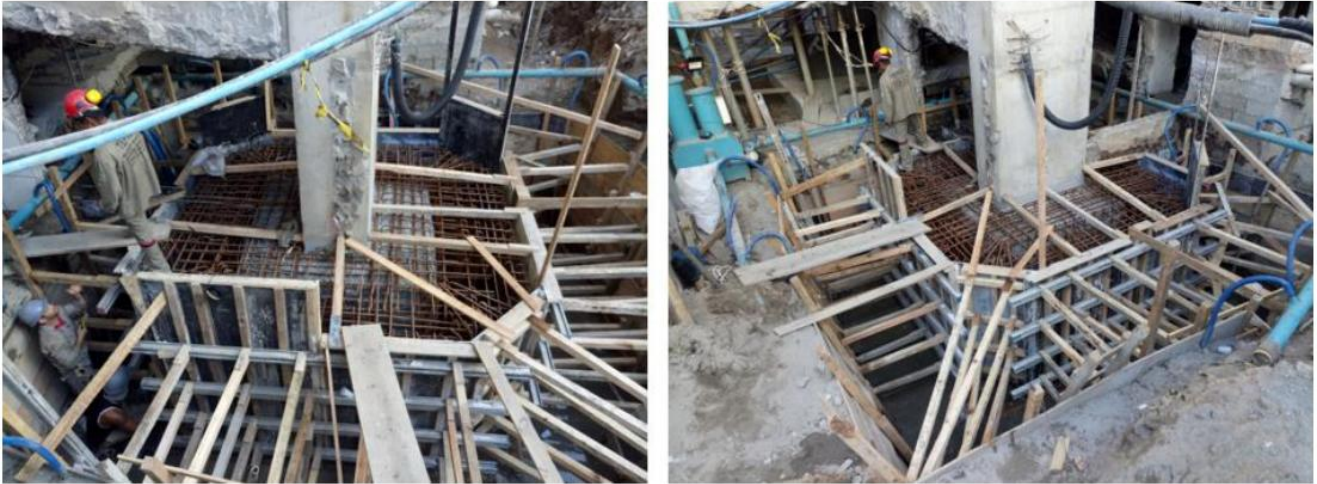
After reviewing and releasing the assembly by the engineering team, the assembly of the wooden and support formwork began, as shown in Figure 14. All these works were also supervised in terms of level, plumb, dimensions, closure and watertightness.

**Figure 14.** Details of the shapes of the structural reinforcement of the foundation pile caps.

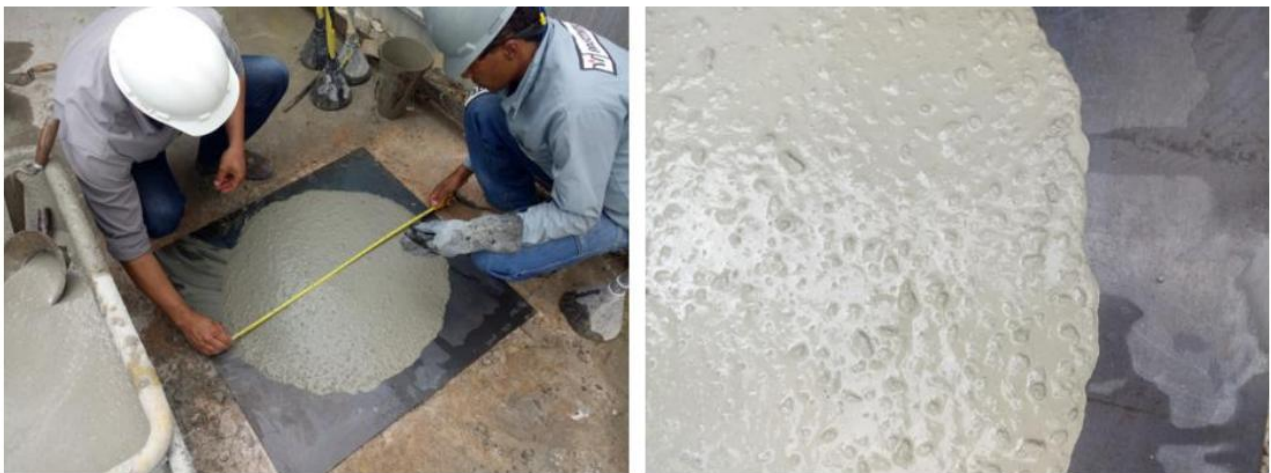
After completing the structural reinforcement work, according to the detailed dose in item 2 of "*Basic Data of Reinforcement Project and Concrete Trace*" in this paper, the reinforcement of structural members was evacuated by self-compacting concrete pumping. Figure 15 shows the visual appearance of the concrete observed in the field.

**Figure 15.** Appearance of self compacting concrete used to reinforce structural formwork.

At this stage, the concrete must be projected at a low speed to prevent air from accumulating on the lower surface of the block, thus avoiding possible hidden emptying failures. In order to avoid the disqualification of this property, the concrete at the lower part of the block is slowly projected to one side of the block and moderately vibrated with an immersion vibrator with a diameter equal to 40mm.

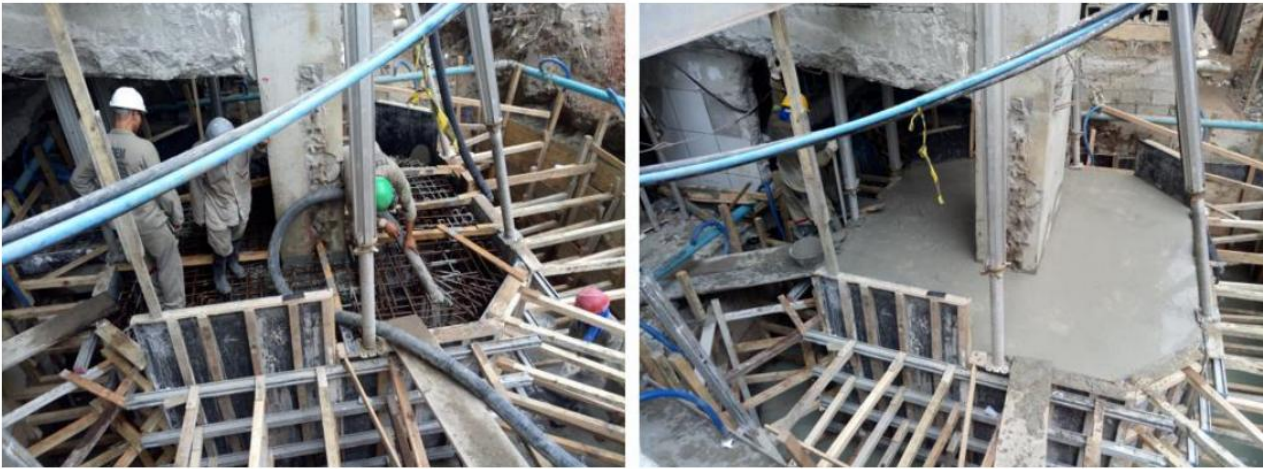
Figure 16 shows a reinforcement emptying event of a foundation block, which was conducted with self compacting concrete, while respecting the premise mentioned in the previous paragraph.

**Figure 16.** The details of the foundation block reinforcement emptying are made of self compacting concrete.

It is important to record that the treated surface of the existing blocks in the new and old concrete interface area was previously cleaned with pressure water to remove all dust, powdery materials or any other contaminants. Self compacting concrete shall be projected onto a clean surface under dry saturated conditions.

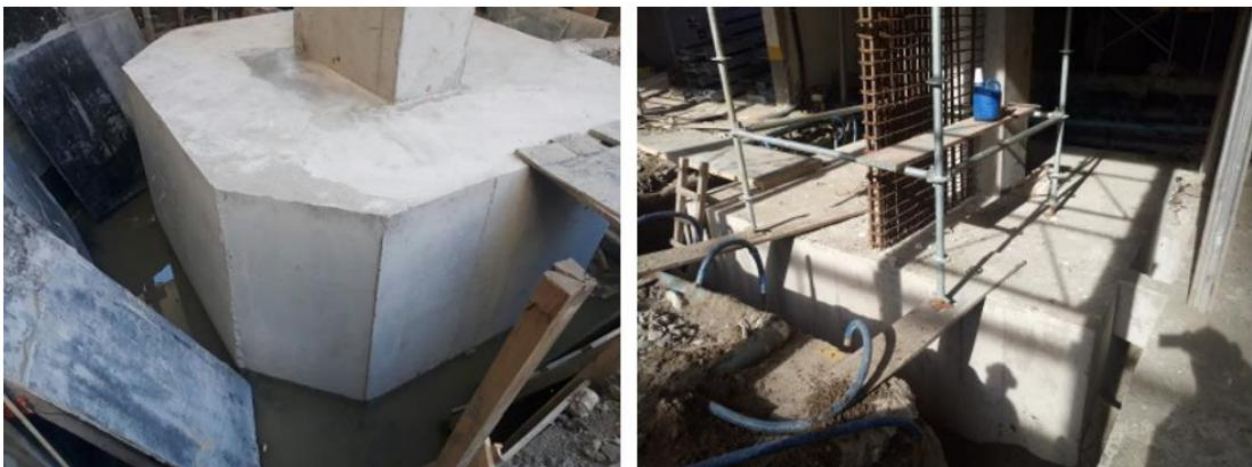
Subsequently, after the removal of the formwork, a thorough inspection of all surfaces of the reinforcement being executed and the area of the new/old concrete interface was carried out. According to records, no nonconformities related to emptying faults, cracks, etc., were found.

Figure 17 shows the appearance and surface finish of hardened concrete used to reinforce the foundation cushion.

**Figure 17.** Details of the appearance and surface finish of the reinforced blinding concrete.

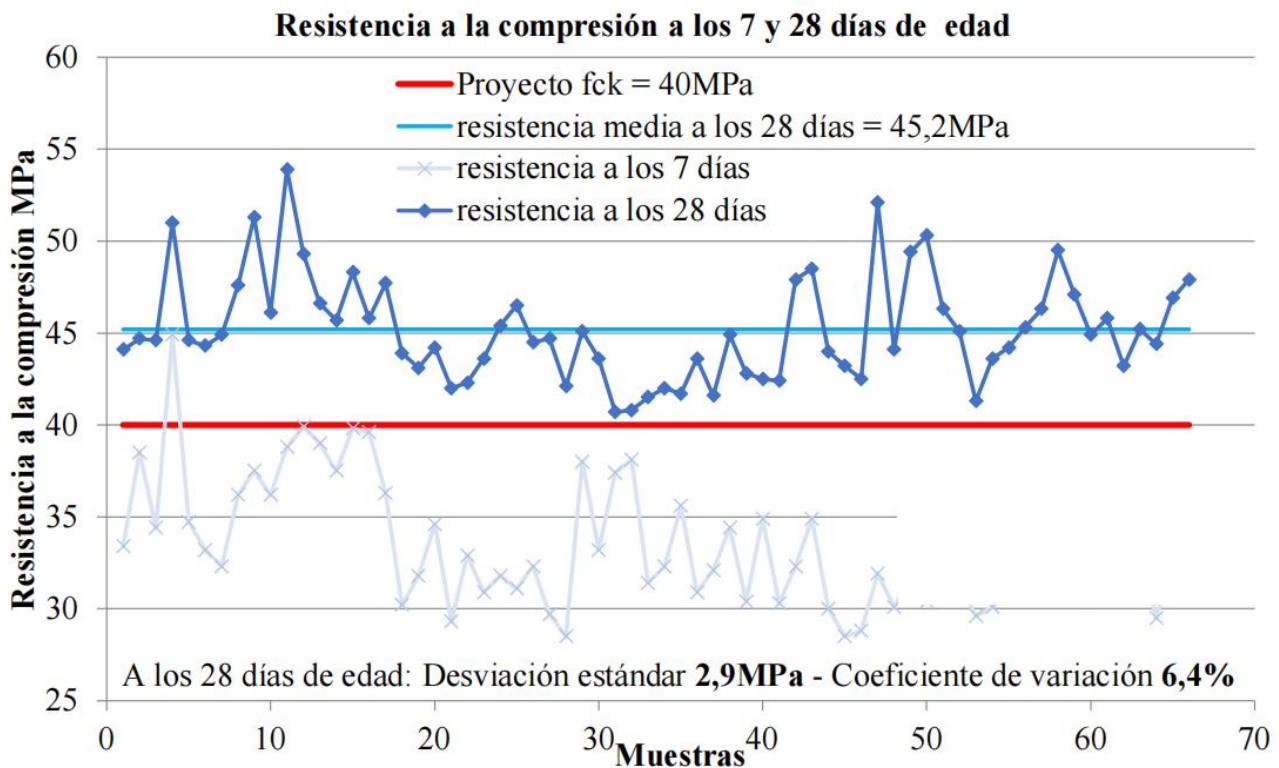
Regarding the technological control of the concrete applied in the structural reinforcement of the pile caps of the residential towers, Figure 18 presents graphically the results of the concrete compressive strength at 7 and 28 days of age of the 66 truck mixers (100% sample), in the form of a chart of individual values.

It can be seen that the average intensity obtained is 45.2MPa, the standard deviation is 2.9MPa, the coefficient of variation is 6.4%, and the extreme value is 40.7MPa (lowest) to 53.9MPa (highest). Considering the resistance specified in the project, all results are consistent.

Figure 18. Chart of individual concrete values  $f_{ck} = 40\text{MPa}$ , self-compacting concrete used in the structural reinforcement of the foundation pile caps.
