The Georadar in the Evaluation of Reinforced Concrete Structures Affected by Corrosion

Abstract: Ground Penetrating Radar (GPR) is a geophysical method that has several applications in the field of civil engineering, one of the largest fields being the evaluation of the technical state of the affected reinforced concrete structures by corrosion. In Cuba, this method has not been widely used as a non destructive test (NDT), largely due to the lack of knowledge of its potential in civil engineering. This article performs a critical analysis of some investigations in which the georadar is applied to evaluate the technical state of tunnels, bridges and buildings. The regulatory framework that protects the use of the georadar as NDT in the world and the applications that it has had so far in Cuba are addressed. The electromagnetic responses of the method to various injuries and causes that cause damage to reinforced concrete such as fractures, cavities, areas of humidity, chloride penetration and corrosion itself are also presented.

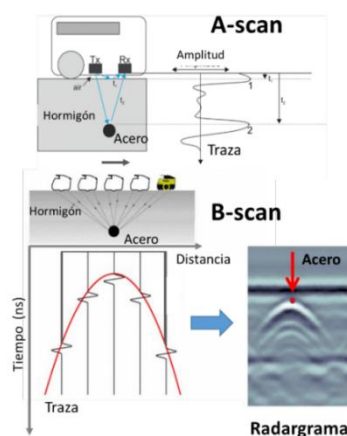
Figure 1

The ground penetrating radar in A-scan (trace) and B-scan (radargram) variants is used for data acquisition. The B-scan variant shows the characteristic reflection hyperbola of steel embedded in concrete or other objects such as pipes and cables. The apex of the hyperbola shows the position of the steel. Taken from Tosti and Ferrante [4]. Author's arrangements.

The georadar includes transmitting high-frequency wave pulses to the medium and receiving reflected and diffracted waves generated by the change of electromagnetic characteristics of the medium. The equipment basically consists of transmitting and receiving antennas, which may be in the same device or separate, and a central unit that controls the emission and reception of the signals. The transmitting antenna emits electromagnetic pulse, which is emitted through the interior of the medium and reflected by all surfaces with different electrical impedance. The reflections on different interfaces are collected by the receiving antenna, and the sum of all these reflections will form the response of the material and be recorded in the track (A-scan). Over time, a group of traces recorded in the material are called radar image (B-scan), Fig. 1.

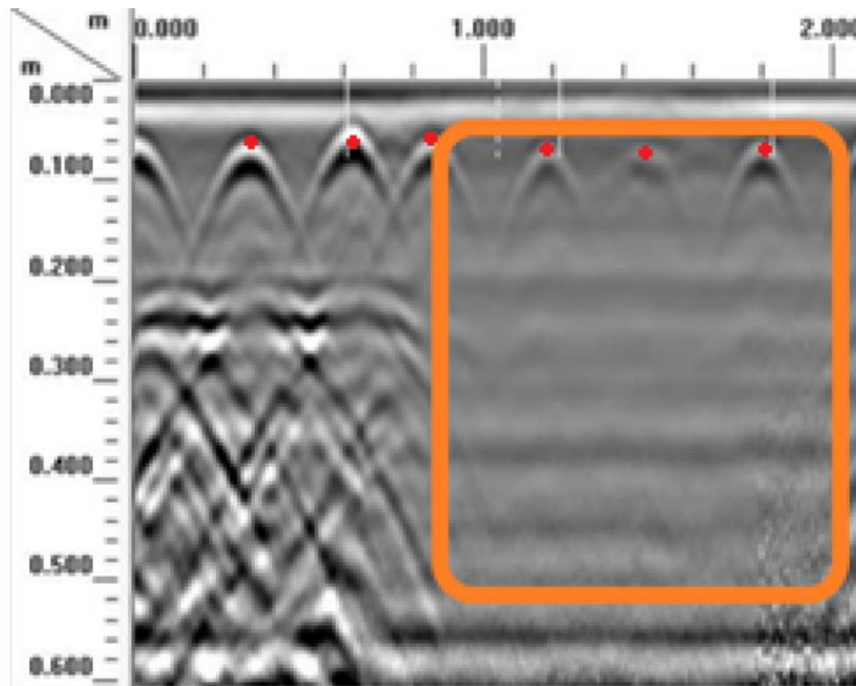
Figure 2

The location of the steel with red dots and the maximum humidity area and corrosion area of the steel in the orange box. Source: Dinh et al., [16].

Dinh et al., [16] conducted a study in the underground parking lot to understand whether the embedded steel is corroded. It is also detected that the signal attenuates to the area at the bottom of the concrete slab (Figure 2). The decrease of amplitude is related to the high humidity in this area, which leads to a sharp decline in the propagation speed of waves. This area can be designated as a corrosion area.

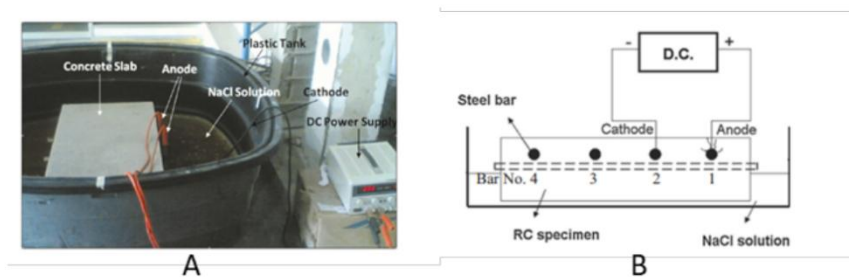
Figure 3

(A) Typical test for corrosion of reinforced concrete. Source: Zaki et al., [34]. (B) The concept outline of anode-cathode clearly shows that in reinforced concrete samples, a kind of steel acts as cathode (reduction) and anode (oxidation) through current when immersed in NaCl solution. Source: Hong et al., [32].

A common method for corrosion test of reinforced concrete is to immerse the reinforced concrete slab in 5% sodium chloride solution [31-34] to accelerate the corrosion process. After a certain time, the sample is extracted and an electric current is applied in the range of 1 Amperes and 10 Volts, then it is measured with the GPR, either punctually or by means of profiles. This test simulates an electrochemical cell, in which one steel is used as the cathode and the other steel is used as the anode, so as to conduct the reduction and oxidation process with reinforced concrete as the medium (Fig. 3). Through this method, the change of electromagnetic signal in each corrosion stage can be observed through continuous measurement, so as to establish a comparative standard for evaluating the corrosion degree of different reinforced concrete structures.

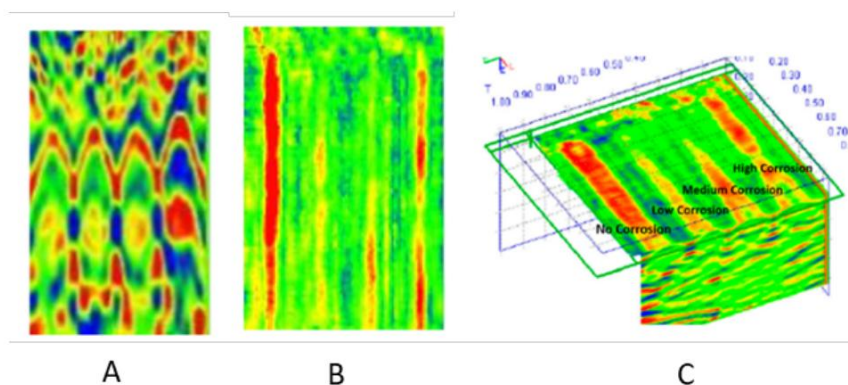
Figure 4

Measurement results: (A) B-scan, (B) C-scan and (C) 3D image. From left to right: non-corrosive steel, low corrosive steel, medium corrosive steel and high corrosive steel. Kabir and Zaki [35].

In order to determine the damage caused by concrete slab corrosion, Kabir and Zaki [35] adopted the methods of GPR and half-cell potential method (HCP). In this case, the steel is placed in sodium chloride solution and impacted with direct current for 1, 3 and 7 days. The steel is then embedded in the concrete mixture. After 28 days of curing, the measurement was carried out with an antenna of 2GHz frequency in three ways: A-scan, B-scan and C-scan (Fig. 4 A, B and C). It was observed that the first type of steel without current supply remained in perfect condition at high strength; on the other hand, with the increase of corrosion exposure days, the vibration amplitude increased, which was proved in the red bar representing the most severely corroded steel.

Lai et al., [36] set guidelines for GPR corrosion research, and Kabir and Zaki [35] compared the results obtained with those of HCP. On the basis of detecting the corrosion of reinforcement, the author timely measured three different stages: sodium chloride pollution stage, dewaxing stage and corrosion stage. They considered three aspects to explain the changes: the propagation time of the wave, the amplitude of the received signal and the peak of the spectrum frequency. It is detected that the maximum positive amplitude of reflected wave changes in different corrosion stages. In the NaCl pollution stage, the amplitude is very high. In the second stage, due to the dewaxing of reinforcement and the reduction of concrete pH value, the concrete pH value decreased, but with the increase of corrosion, the amplitude began to increase with the passage of time. The propagation time of the wave is increasing at each stage, while the frequency of the spectral peak is always increasing. On the other hand, by analyzing the results of half-cell potential, it can be seen that the area with the most serious corrosion is located in the area with the highest potential.
