# Investigation of Crack Causes and Structural Limit State Check of Active Hollow Slab Bridge

**Abstract:** Aiming at the cracks of the hollow slab bridge in service, a special on-site traffic survey is carried out. Based on the survey, the limit state of the hollow slab bearing capacity is checked, and the internal and external causes of the cracks in the hollow slab are analyzed to provide subsequent reinforcement treatment in accordance with.

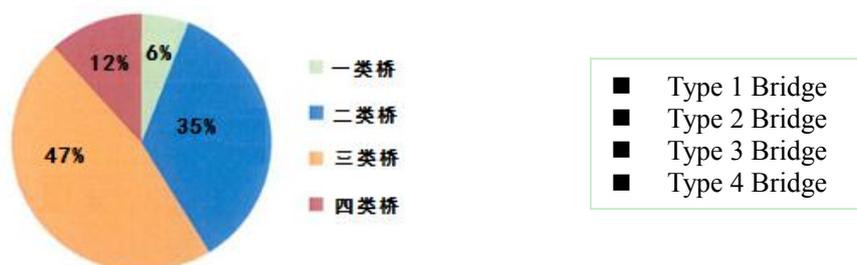
An expressway is an important part of the National Highway Network Plan. There are 170 bridges on this high-speed down line. Except for the K136 + 560 down line which is a 1-180m box-rib arch bridge, the remaining bridges are all 20m and 30m post-tensioned pre-stressed concrete wide hollow slabs. According to the "Regular Inspection Report of Bridge Maintenance for This Section (2017)", the technical status of the downstream bridges on a certain section is shown in Figure 1. Among the 170 bridges on this section, there are 10 Class 1 bridges, accounting for 5.88% of the total number of bridges; There are 60 types of bridges, accounting for 35.29% of the total number of bridges; 80 types of bridges, accounting for 47.06% of the total number of bridges; 20 types of bridges, accounting for 11.76% of the total number of bridges. The technical status of the bridges in this section is rated as Class 3 or 4 bridges, accounting for 58.82% of the total number of bridges in this section, and the bridge is in a serious condition.

Figure 1. Technical status of downlink bridges on a section

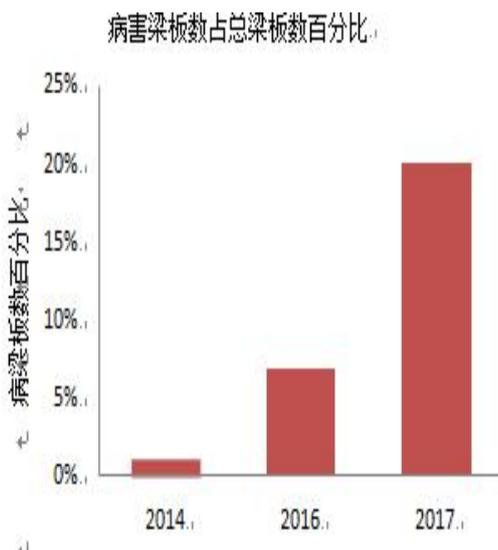
Through statistical comparison of the damage conditions of beams and slabs in the inspection reports in 2014, 2016 and 2017, the growth trend of the downward link bridge is shown in Figure 2 and the downward link bridge growth is shown in Figure 3. The main disease of this type of hollow plate is that there are a large number of diagonal shear shown in shown in Figure 3. The main disease of this type of hollow plate is that there are a large number of diagonal shear cracks

Figure 3. Histogram of downward bridge disease growth

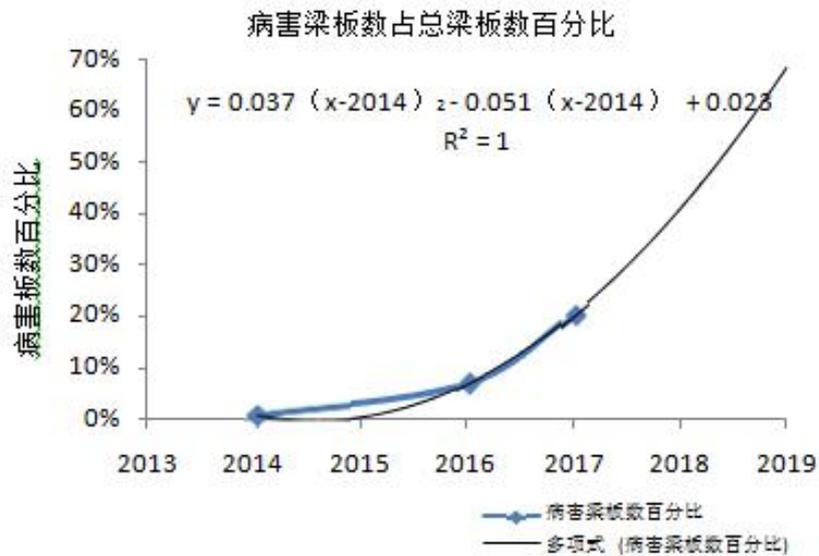
According to the change law of the development of bridge diseases on the high-speed downward line from 2014 to 2017, through curve fitting, a model for predicting the growth of bridge diseases can be obtained, which can predict the trend of the development degree of bridge diseases on this road section without effective reinforcement treatment. After fitting, the change trend of the development of the high-speed downlink bridge disease is shown in Figure 4. According to the binomial formula,  $y = 0.037(X-2014)^2 - 0.051(X-2014) + 0.023$  ( $R^2 = 1$ ) Growth: In the formula: X—year;  $R^2$ —

goodness of fit. The range of R value is [0,1]; y—the number of diseased beam plates as a percentage of the total beam plates. The prediction model of disease development is based on the data of the detection report from 2014 to 2017, and the function of the disease is estimated by curve fitting correction to estimate the development of the disease. The actual growth pattern of the disease may differ from the model prediction.

**Figure 4.** Forecast of the growth of down-Line bridge diseases

According to the predictive analysis model, it can be obtained that without effective reinforcement treatment, it is expected that by 2018, the number of disease beams and slabs on the high-speed downlink bridge will account for 41.1% of the total number of slabs; by 2019, this proportion will reach 69.3%. According to the prediction model, the development law of bridge diseases will increase at a rate of about 20% after 2016. The development of bridge diseases is not optimistic, so it is imminent to take effective curative measures for bridge diseases on this section.
