Conservation of Housing Heritage in Coastal Areas: The Siboney Case

Abstract: The objective of this study was to conduct a pathological study of four existing housing typologies in the coastal settlement of Siboney in Santiago de Cuba, as this area is one of the highest-priority community councils for the projections contemplated in the country's strategy to address climate change. The measurement equipment and methods used for the diagnosis and characterization of the coastal settlement of Siboney are described. A survey of damage, their causes, assessments based on measurement results, and an update of technical specifications were conducted. It was stated that minimizing risks in the life cycle of buildings in coastal areas allows for planning work and resources to achieve the quality and flexibility of the areas and facilities, so that the combination of these results leads to the proposal of appropriate actions for the conservation of these buildings.

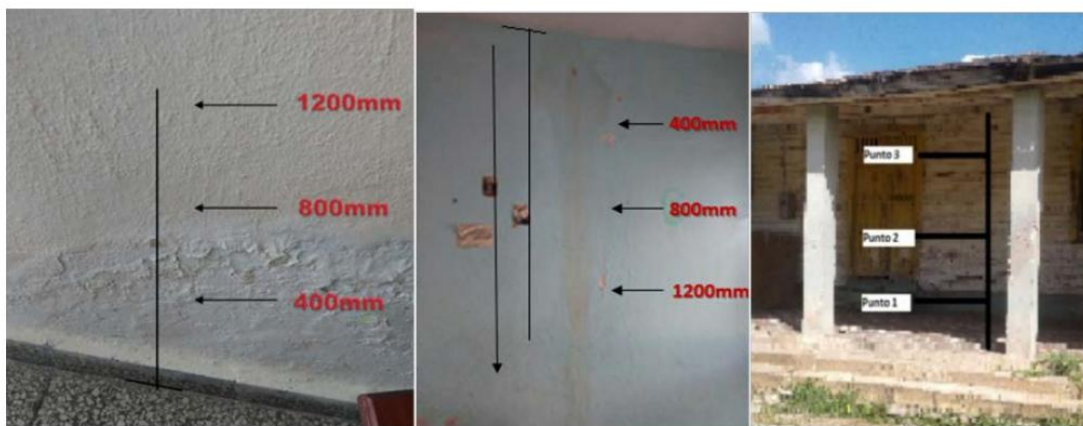
Figure 4. Representation of the points in the measurement zones applied to the 4 typologies. (Authors)

As the first step, the measurement points were defined. First, it is important to clarify that this work refers to two types of measurements: one was taken on walls from the ground to the slab with three measurement points, and the other, from the slab to the ground with three measurement points in the case of typologies I and II. For typologies III and VI, measurements were taken at three points only on the walls. (Figure 4).

The measurements showed that the highest moisture values were found at the points closest to the ground, demonstrating the existence of a damp source generating this lesion and allowing it to be classified as rising damp.

If a dispersion of values is observed between measurement points, the infiltration of moisture is considered to be caused by water seeping out from the outside of the building, just like in the case of Type IV (wooden buildings). Experimental verification of the humidity levels in the homes allowed for a direct relationship with the visual observations, as the presence of this damage was evident in all cases and that values, even considered low, affect the proper functioning of the buildings and can generate other secondary damage.
