Renovation of the Santiago Bernabéu Stadium. Live with the past: evaluation and reinforcement of the original structure

José Luis Martínez Martínez*, José Antonio Martín-Caro Álamo

Ines Ingenieros, Núñez de Balboa 120, Madrid, Spain

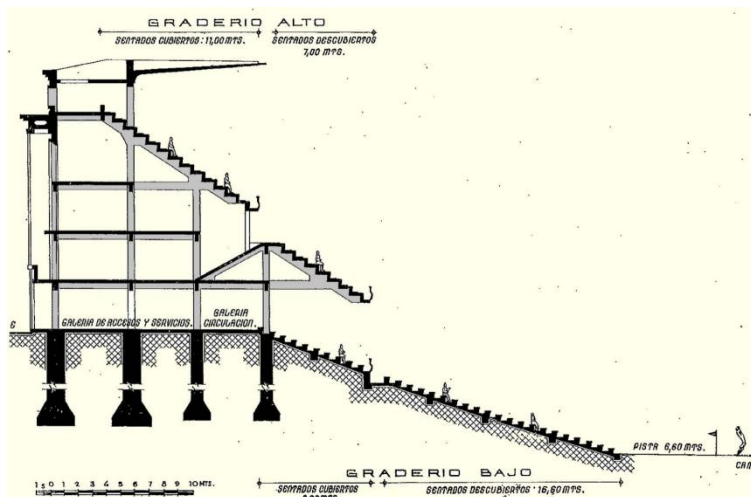
The playing field and the lower stands, made of mass concrete, are buried in the ground, set about 8 m below street level. The cross-section (see Figure 1) features four rows of columns founded on mass concrete piles ("pilarotes") with widened bases. The columns have a constant square cross-section throughout their height (sides ranging from 0.40 to 0.55 m). The spans vary between 4.50 and 5.50 m. The structure consists of two tiers, the first amphitheater cantilevered over the lower tier and the second tier above it and set back toward the exterior. These reinforced concrete porticos that form the cross-section are spaced 7.00 m apart and consist of beams measuring 0.30 x 0.55 m (width x depth). In the longitudinal direction, the beams measure 0.30 x 0.65 m and feature half-lap joints at one-quarter of the span every 3, 4, or 5 bays, simulating continuous flexural behavior while maintaining very moderate expansion lengths. The four floor levels are

Figure 1. Typical cross-section on the west side of the original stadium (1944–1947). The upper canopy, with a 10-meter overhang, was never built

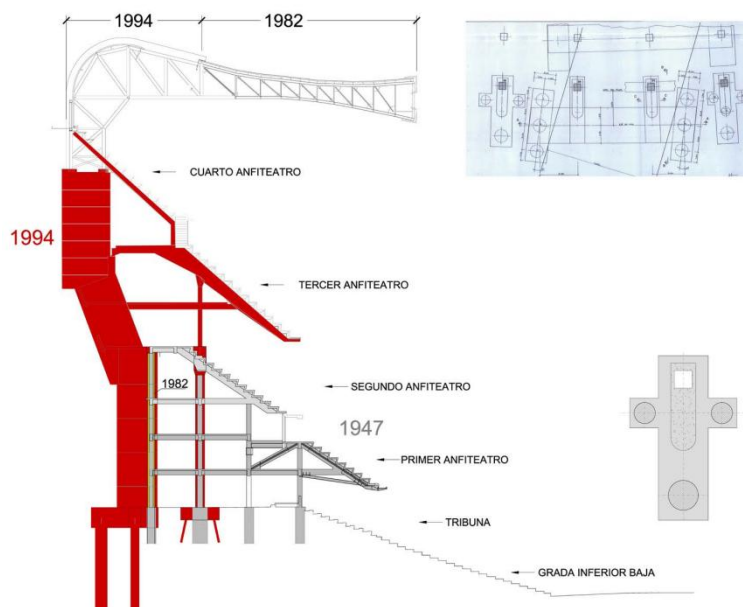
Figure 3. West cross-section and end areas after the 1994 expansion, foundation plan of a typical rib (bottom right) and reinforcement of the bridge structures over the tunnel on the south side (top right)

Figure 3 shows the cross-section resulting from the 1994 expansion. The two new amphitheaters rest on the pillars of the first and second alignments, while the roof is raised vertically and complemented by a new curved section that allows it to be embedded in the rib of the 4th alignment. The second-row pier receives a vertical reaction from the new structure, so its cross-section is reinforced with a perimeter extension and its foundation is micro-piled.
