Stress-strain Analysis of the Remediation Works Implemented to Stabilize the Mining Subsidence Under the La Inmaculada School, Zaruma-Ecuador

Abstract: This work establishes 4 stress-deformational scenarios that show the instability process and remediation works, in relation to the subsidence event and collapse of the land where the school La Inmaculada (Zaruma-Ecuador) was established. Longitudinal profiles were used in the direction of the exploitation of the "Tres Reyes" vein where the geological-structural model that serves as a basis for the calculation of the deformations in the mining galleries around their plastic behavior is shown. For the modeling, it was necessary to determine, the dead load of the infrastructure, pseudo-static loads, positioning of the water table, physical-mechanical-elastic parameters of the rock matrix and discontinuities that together define the behavior of stress and deformation by means of the numerical technique of Finite Element Method (FEM). Design an optimized mortar with a dosage of 1 cement (C): 2 tailings (R) and a water (A)/cement (C) ratio of 0.49 to obtain a strength of 18 MPa after 14 days of curing. Finally, it is proved that the appl

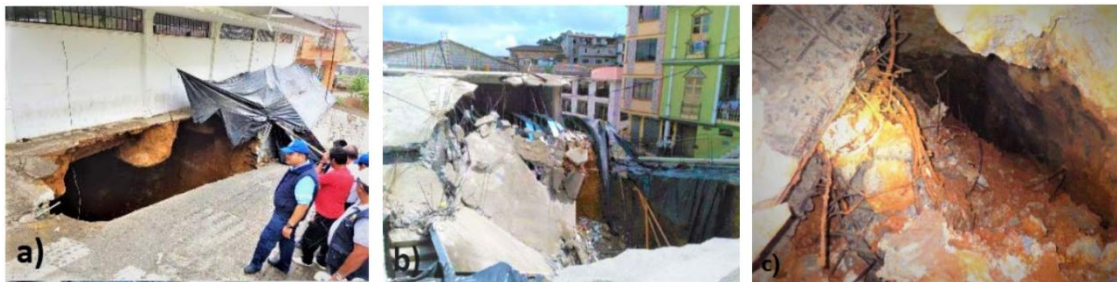
Figure 2. a) Beginning of collapse with a 10 m cone. b) Destabilization of structures. c) Debris (columns, hoses, cables, blocks) inside the gallery that caused the subsidence of the ground at surface.

The land subsidence, which occurred on October 25, 2016, at the "La Inmaculada" school in the city of Zaruma, is related to the settlement of the rocky massif and the formation of an initial cone of 10 m in diameter that gradually increased to 23 m, compromising the safety of the inhabitants and the structural stability of the surrounding houses (Fig. 2).

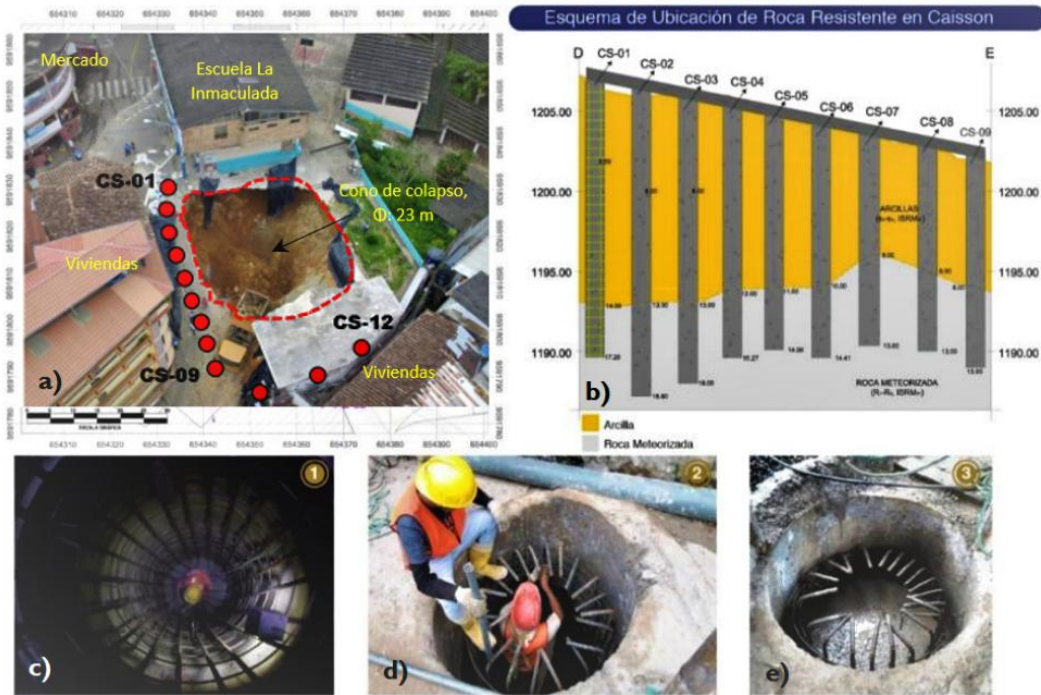
Figure 3. a) Spatial distribution of the caisson piles. b) Profile with the location of the piles in soft rock (16.76 MPa). c and d) upward iron reinforcement process. e) 280 kg/cm² concrete curing process.

Phase 2 (remediation) is based on the construction "IN SITU" of 12 caisson-type piles (structural concrete of 280 kg/cm² with steel reinforcement f_y : 4200 kg/cm²) with an internal diameter of 1.2 m, placed every 3 m, embedded in the rock at an average depth of 19 m, supported by a tie-beam and a reinforced structural screen, which together form a perimeter structure whose objective is to stabilize the houses near the subsidence zone (Fig. 3). Subsequently, the interior of the cone was cleaned until reaching the competent rock, where a $\pm 4\text{m} \times \pm 5\text{m}$ capping slab was built with a reinforced structure (0.40 m rebar + electrowelded mesh + perimeter beam + 16 anchored micropiles + double iron grillage with Φ : 18 mm @ 0.14 m + HB profiles + 0.40 cm of 350 Kg/cm² concrete) and drainage. Finally, the backfilling of the cavity is with 6,000 m³ of compacted till material (sub-base class 3) up to the natural ground profile (Fig. 4) (INIGEMM, 2017).

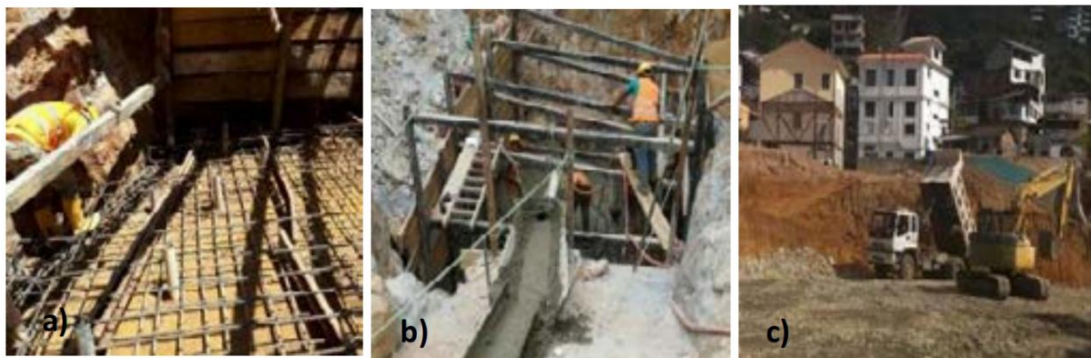
Figure 4. a) Backfill + drains + perimeter beam + iron reinforcement. b) Casting of slab. c) Backfill with compacted material Sub-Base class 3.

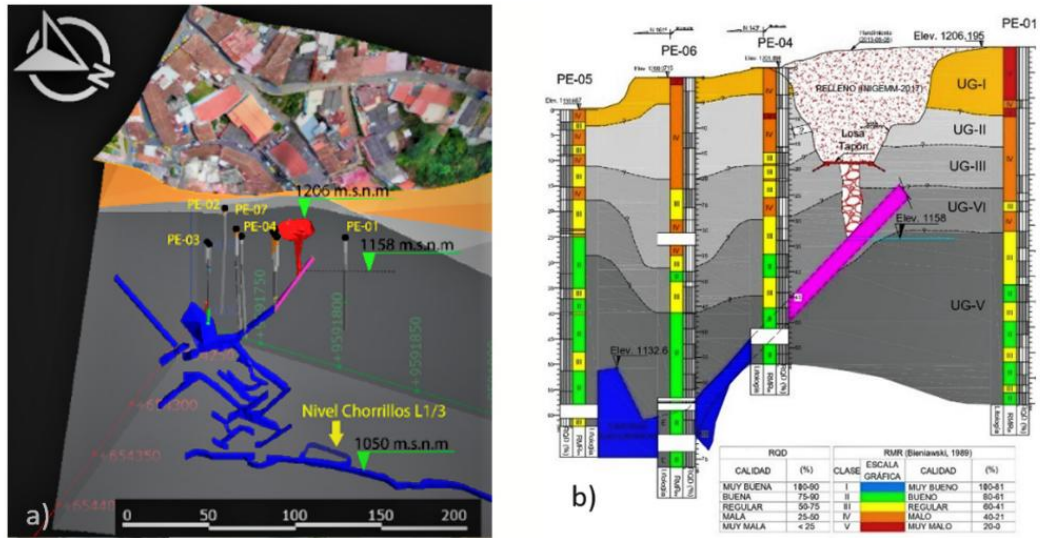
Figure 6. a) 3D geological-geotechnical model. b) Section between exploratory drillings PE-01, PE-04, PE-06, PE-05, showing 5 levels of weathering, RQD and the quality of the rock mass according to Bieniawski (1989). Source: Modified INIGEMM (2017) and Rivadeneira, A. (2021).

Figure 6 represents the geological model integrating the spatial distribution of the galleries that exploited the "Tres Reyes" vein (blue solid) from the so-called Chorillos L1/3 level (elevation: ± 1050 m.a.s.l.), ascending through multiple mining excavations (baul-irregular sections between ± 5 and ± 45 m²) inclined at 45° (stopes). The gallery located at elevation ± 1158 m.a.s.l. m (magenta solid) was the cause of the instability of the rock mass under the La Inmaculada school, where the conditioning factors (low lithostatic load, intense weathering, unfavorable geological structures, minimal geomechanical properties) and triggers (high rainfall, static load of the classrooms, dynamic load due to blasting, change in the geomechanical properties of the school, change in the rock mass, etc.) were the cause of the instability of the rock mass, dynamic load due to blasting, change of the tensional state due to mining excavations) had an impact on the loss of resistance of the rock mass, initially producing an accelerated phenomenon of subsidence of the terrain, followed by subsidence with the formation of a cone of up to 23 m in diameter (elevation ± 1206 m. s.n.m.) and a collapse chimney of ± 40 m in length (red solid), (INIGEMM, 2017).

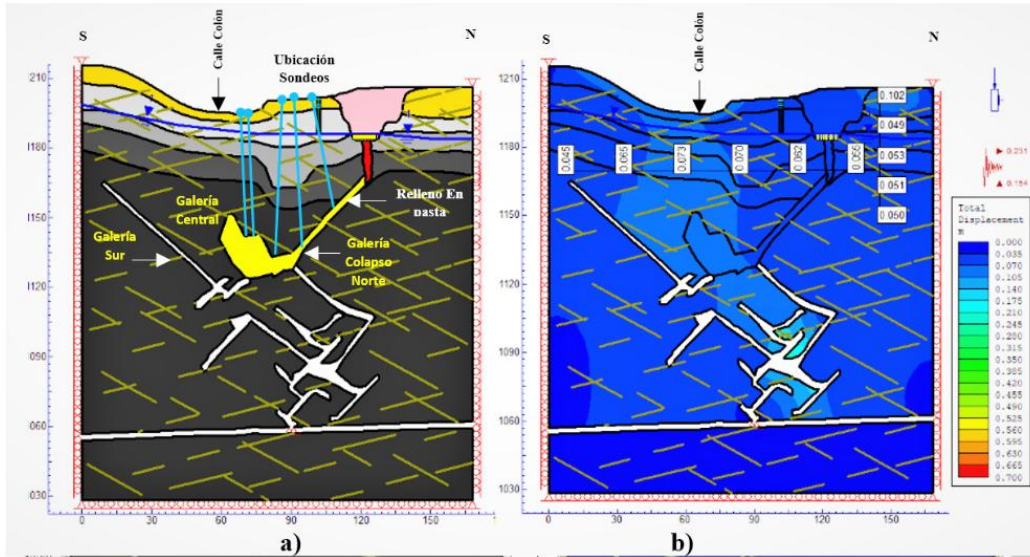
Figure 11. a) Geological model, mitigation works and mortar backfill. b) Deformation behavior after backfilling with mortar.

Geological model: Figure 11a shows the geological environment, the mitigation works and the backfill proposal with a mortar design (1 cement: 2 tailings). The injection of mining excavations is proposed from the surface using 5 boreholes

Stress-strain model: Figure 11b shows the effectiveness of the backfilling with mortar using tailings sand as fine aggregate, and the mortar designed after 14 days reached a simple compressive strength of 10 MPa. The stress-strain model specifically in the backfill zone shows values of less than 6 mm. The general behavior of the deformation in relation to other galleries decreases substantially, i.e., the advance of the plasticized zones is attenuated once the upper excavations are stabilized.

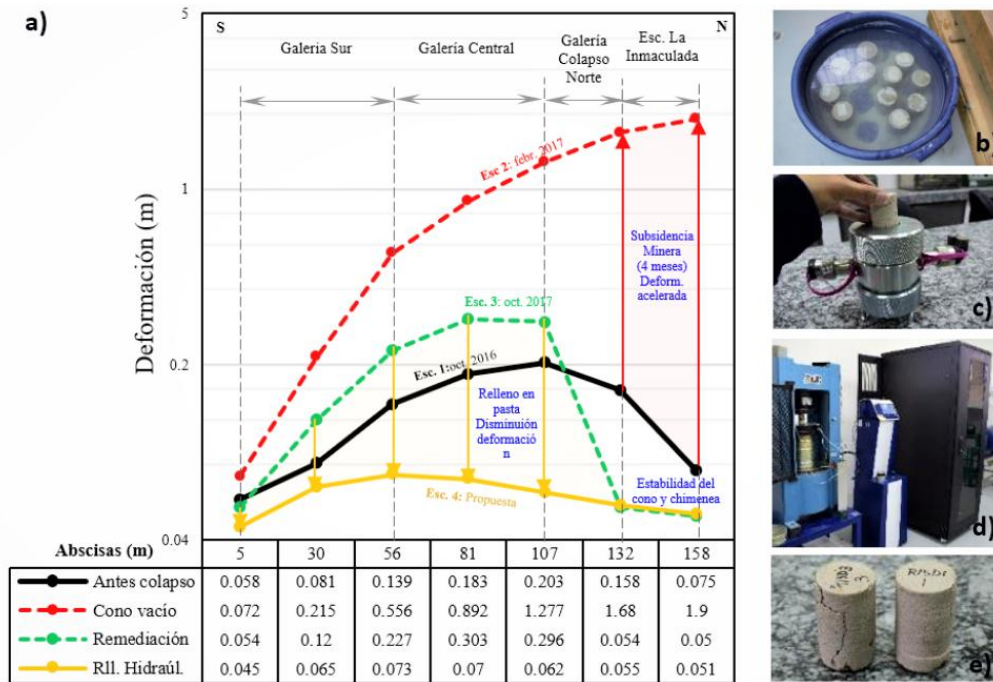
Figure 12. a) Relationship between x-axis distance (Scenarios 1-4) and maximum deformation for the events: before collapse (October 2016), gradual enlargement of the collapse cone and chimney (February 2017), implementation of remediation works (October 2017). b) Mortar cylinders (1C:2R) c) Hoek cell for triaxial test d) Execution of simple compression test with moduli e) Tailings and cement cylinders after rupture.

The four stress-strain models show the state of plastification of the rock massif, due to the presence of the mining galleries under the vicinity of La Inmaculada school. Figure 12a shows the results of the investigation, relating the deformation for each event with the location of the galleries in the longitudinal section with north-south direction:

Scenario 1, Before collapse (October 2016): The deformation curve is maximum in the area between the central gallery and northern gallery; it reaches displacement values between 10 mm to 20 mm, i.e. the development and advance of these galleries disturbed the tensor state, resulting in the plasticization of the rock mass between abscissae 0 + 50 and 0 + 132.

Scenario 2, Empty cone (February 2017): From the first instability event, the collapse cone and chimney increased its diameter due to rock distension and stress state modification, conditioning factors (lithology, favorable geological structures, weathering) and triggers (static and dynamic loads due to blasting and earthquakes, alteration of the stress state, infiltration of runoff water), allowed a decrease in the resistance of the rock massif, causing subsidence of the terrain to consequently produce subsidence of the same.

Scenario 3, Remediation (October 2017): The mitigation works designed by INIGEMM (2017) in the area under La Inmaculada school, minimized the deformation up to 5 mm, achieving the stability of this sector. On the other hand, the deformation between the central and northern galleries (abscissae 0 + 50 and 0 + 132) present values of up to 30 mm, demarcating an area susceptible to mining subsidence. It is imperative that the competent authorities consider the following suggestions:

Scenario 4, Backfilling with tailings mortar (proposed): The deformation curve shows values less than 7 mm, revealing the possibility of backfilling based on cement mortar with tailings (Fig. 12 b, c, d, e), with a favorable mechanical behavior of the rock mass by returning the lost tensional state, disappearing the subsidence effects. This confirms the replicability of mortar backfilling in other existing tunnels under the city of Zaruma, using the ideal elevation for plug placement of over 1110 m above sea level as a reference. On the other hand, it is an effective proposal to solve the problem of environmental contamination of the upper Puyango river basin caused by leachate from the tailings dams.
