# Irrigation and drainage in pineapple crop (cultivar MD-2) in Ciego de Ávila province

Agricultural Engineering Research Institute, Camaguey Subsidiary, Cuba

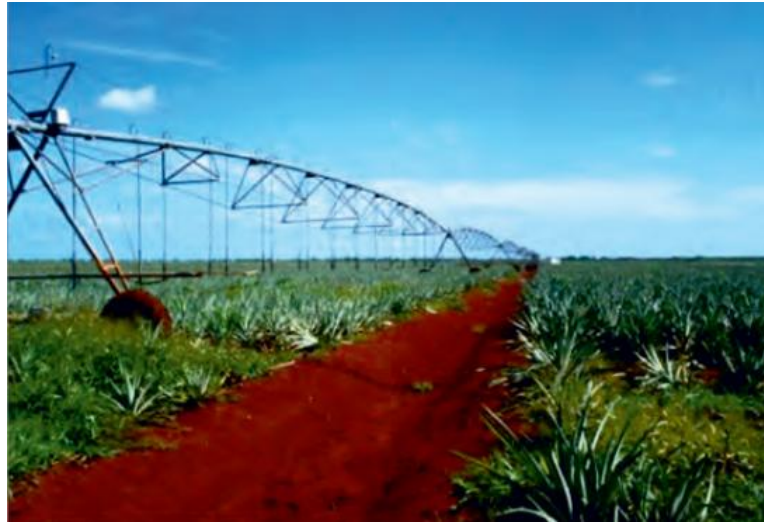
The available irrigation technology comes from the pivot machine of the power plant (Fig. 1).

Fig.1. Irrigation and drainage of Ciego de Á vila pineapple (planting MD-2).

The existing irrigation technology poses an additional obstacle to the normal operation of the drainage network, because the passage of the tower wheel gradually deforms the drainage channel, making it difficult to operate normally.
